Structural Evaluation of the Teton County Solid Waste Transfer Station

June 2013 Final Report

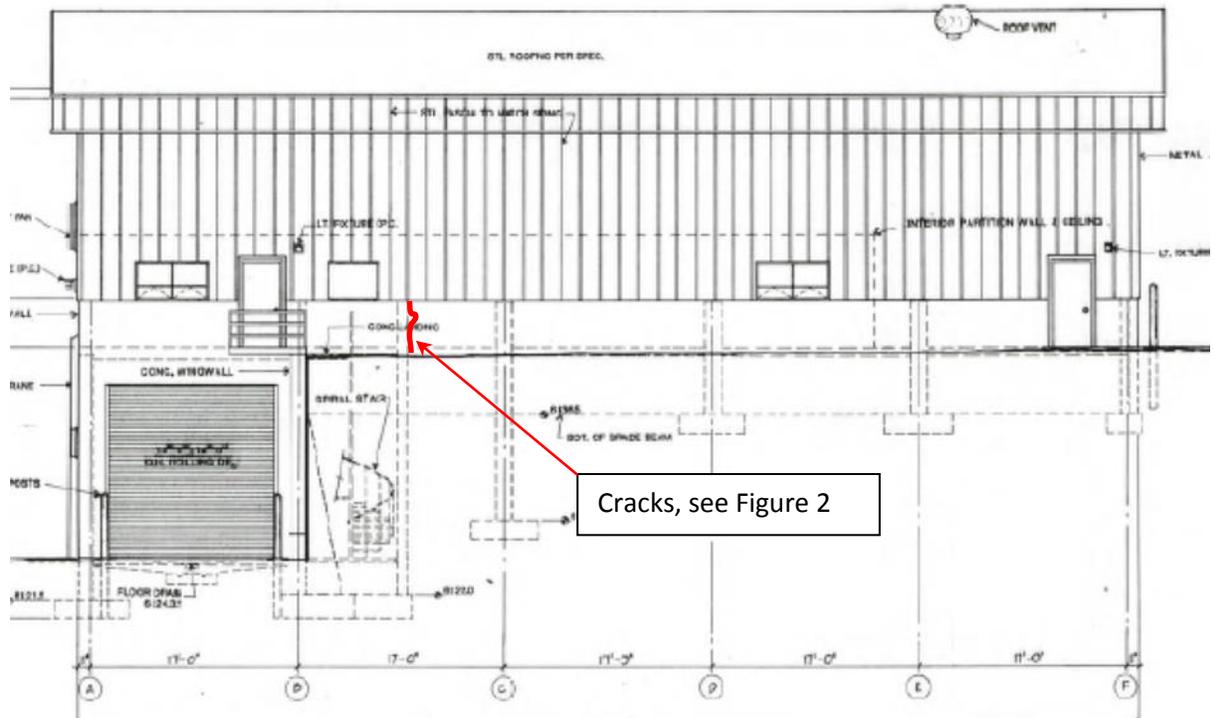
Figure 1

Based on initial observations, the existing structure shows signs of differential movement of the foundations system. The major indication of this is the appearance of cracking in the foundation wall system on the north and south side of the building. In two locations, the cracking is quite severe; see Figures 1 through 4 for pictures and locations of these cracks. These cracks appear to be located at the transition between the deep and shallow foundation walls. It also appears that sometime in the past, the crack on the south side of the building was patched, and that patch has subsequently cracked again, indicating foundation movement is still present.

Based on this information, it becomes evident the addition of the water to the surrounding soils has caused the soil and possible trash under the foundation to consolidate and settle. There is also evidence to suggest the fill soils are susceptible to movement from seismic activity. Both these factors are what caused the foundation movements, wall fractures and wall cracking.

Merrick recommends the severe cracking on the north and south side of the building be repaired and monitored for further foundation movement. It is also our recommendation that gutters and downspouts be properly installed and flashed at the existing facility eaves to channel water away from the building perimeter.

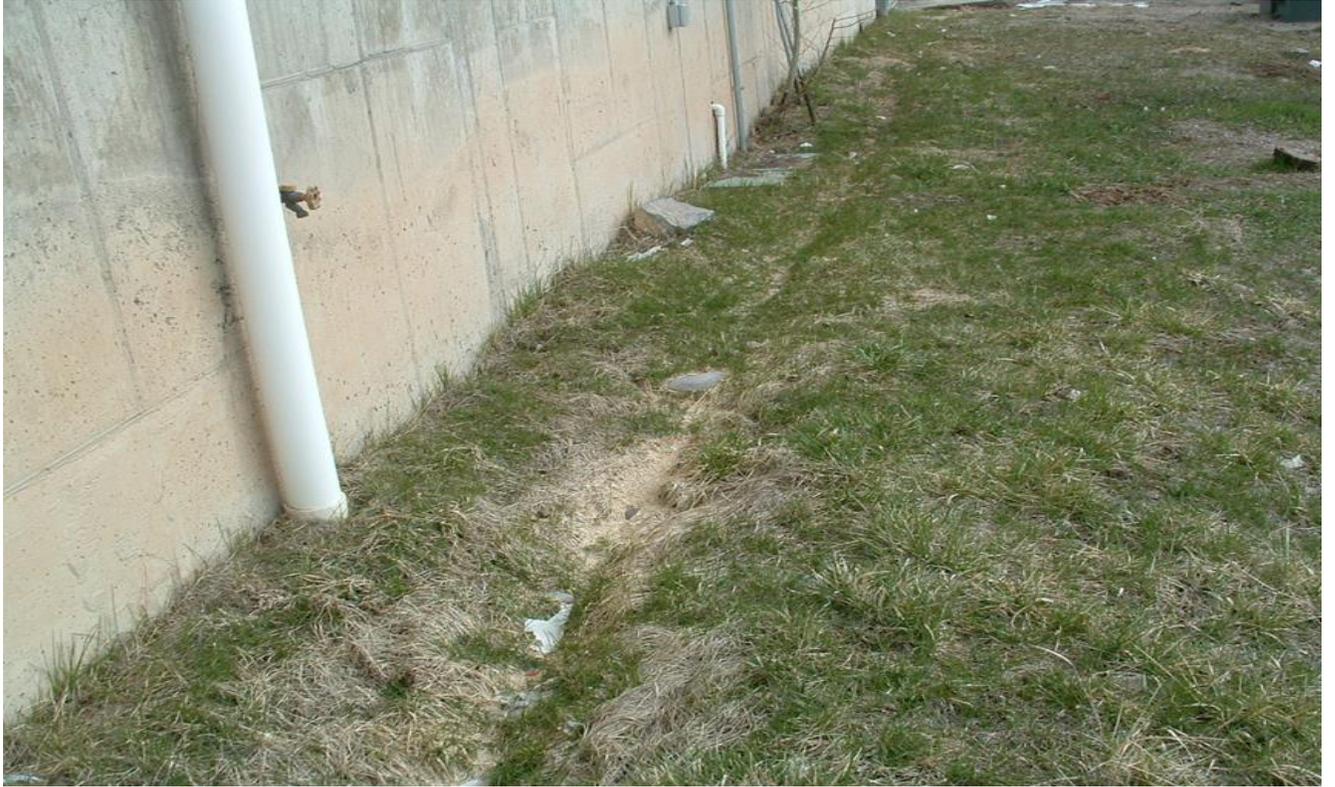
To understand why this cracking is occurring, we need to determine what was causing the foundation movement. In Merrick's conversations with Kent Jaspersen of Teton County, it was determined that at one time there was a broken water pipe under the building that was feeding water into the surrounding soils. Additionally, it was discovered during the site visit that the building currently does not have any gutters or downspouts which typically are used to channel rainwater and snowmelt away from the building foundation. Without these elements, all of the water from the roof has been funneled into the soils around the foundation. See Figure 5 which shows indentations in the surrounding grade of the building where this runoff has been falling. It was also brought to Merrick's attention that during an earthquake, the crack on the north side of the building became worse which would indicate that the surrounding fill are susceptible to movement during a seismic event. This is evident by the surface rupture which occurred during the earthquake and lies within 100 ft of the building; see Figure 6.
