# **SOUTH PARK PATHWAY CONNECTOR TREE SURVEY**

**Prepared for  
Brian Schilling  
Jackson Hole Community Pathways**

**Prepared by  
Todd M. Fitzgerald**

**December 28, 2015**

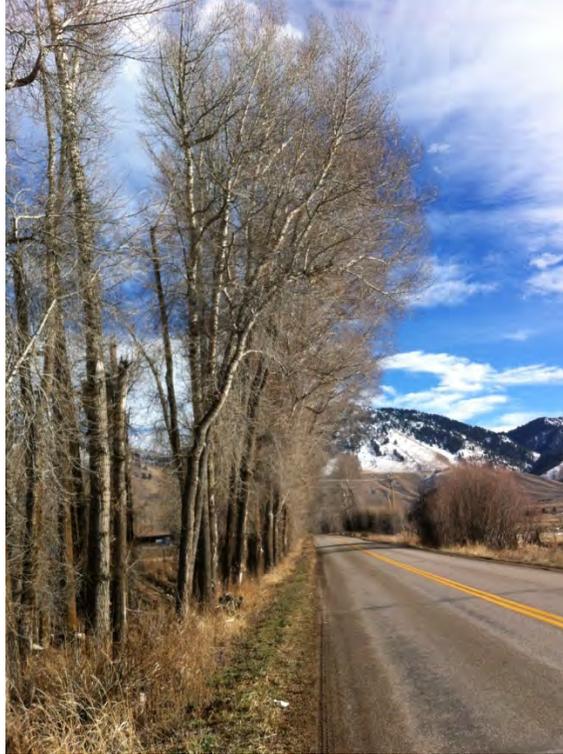
Photo # 1: Looking East from approximate location of tree #515

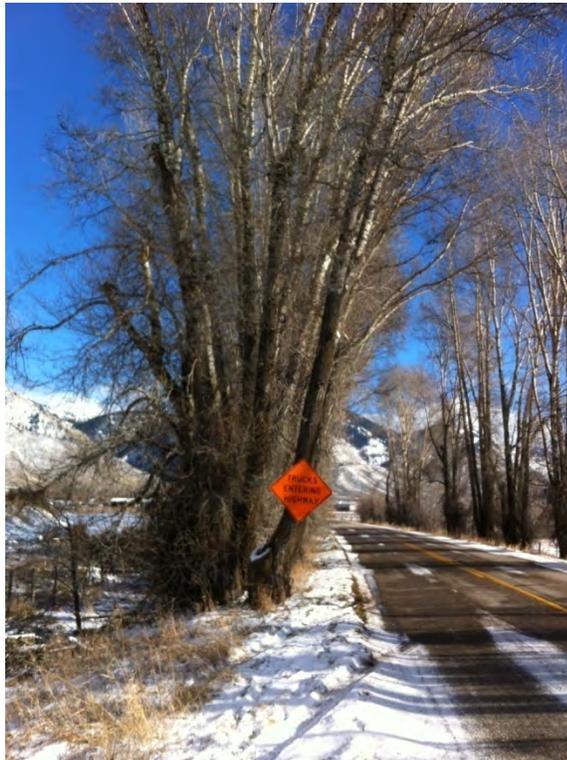
Photo # 2 : Looking East at tree #722.

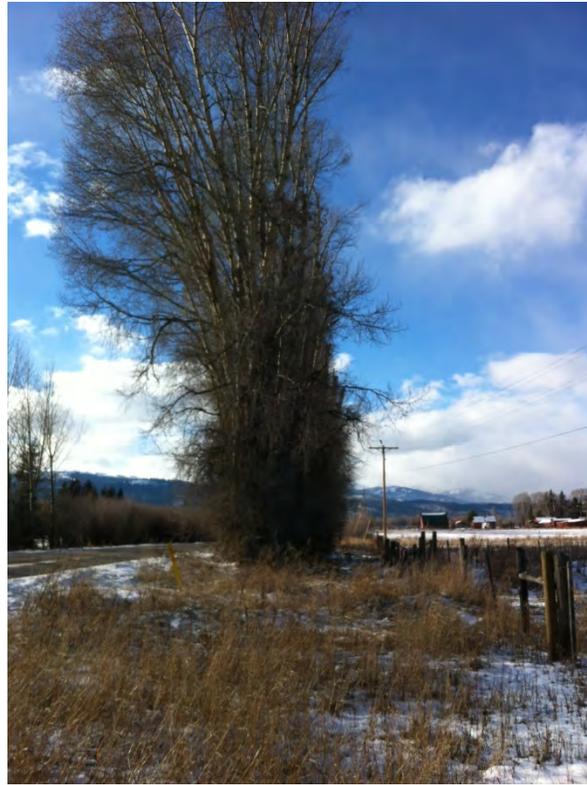
Photo #3: Looking West at stand of trees starting with tree #723.  
Photo #4: Crossing and rubbing stems.

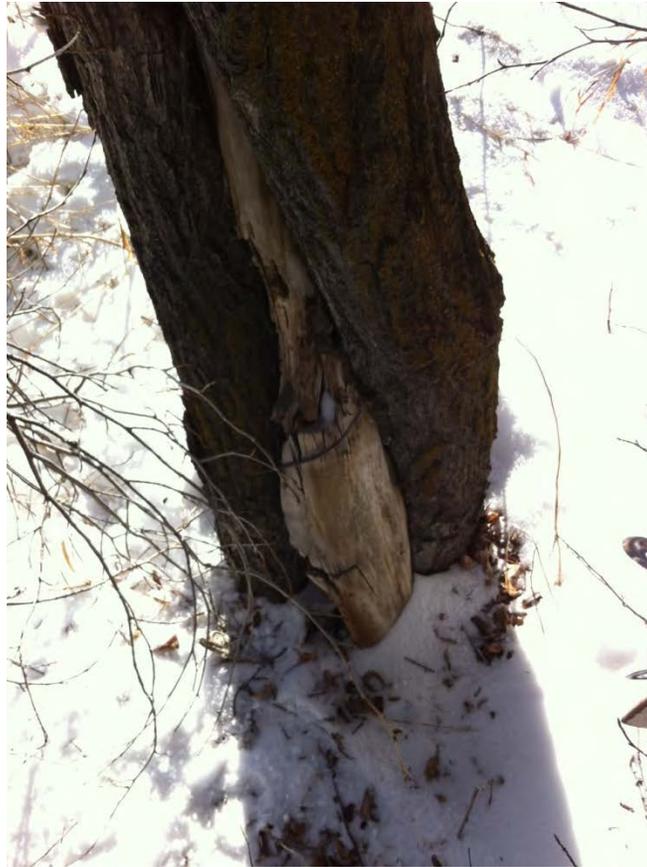
Photo #8: Base of co-dominant stems with wound on bottom right.

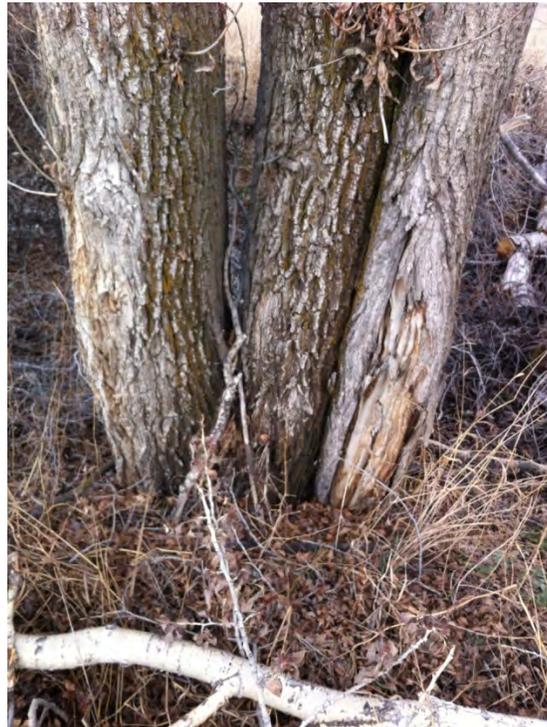
Photo #9: Tree #722 with decay cavity associated with removal of co-dominant stem.

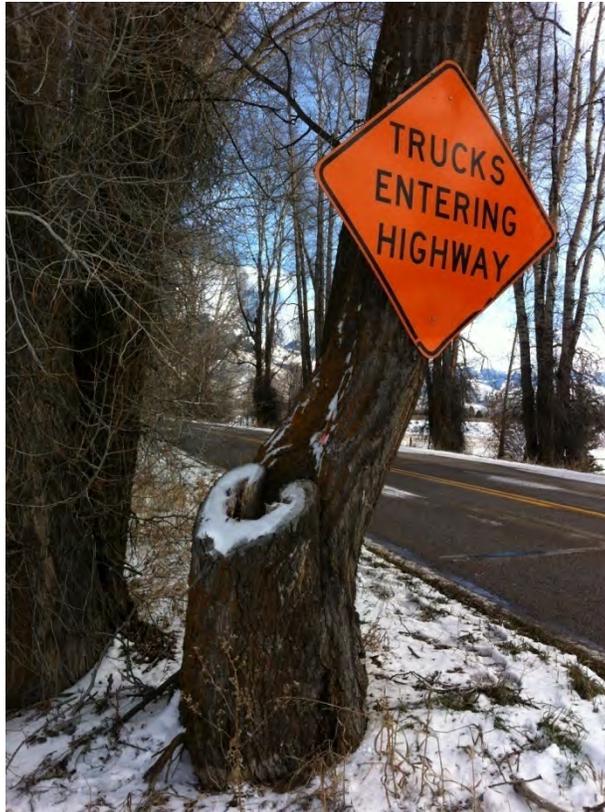
Photo #10: Co-dominant stems.

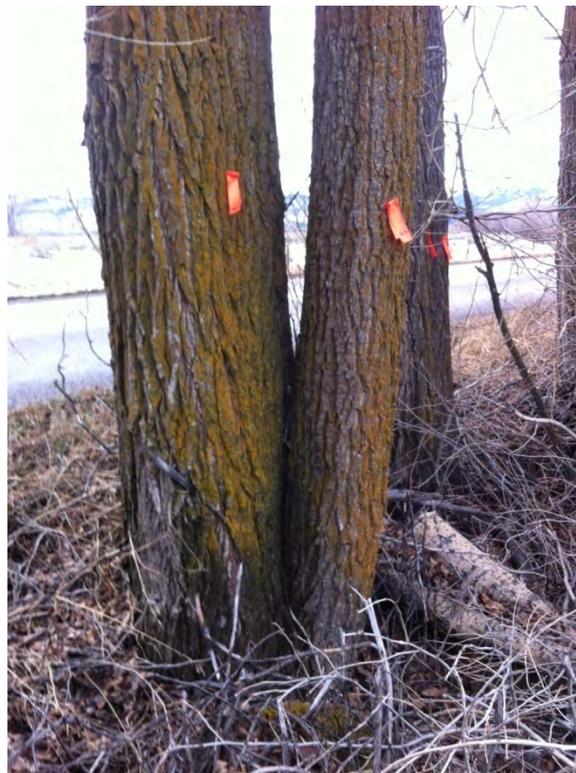
Photo #11: Cluster of multiple co-dominant stems.

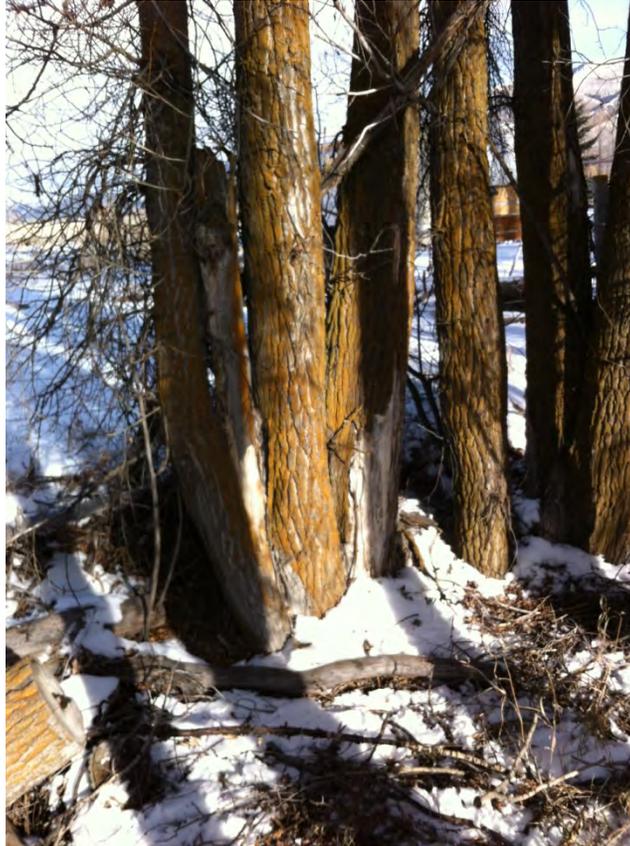
Photo #12: Evidence of past failure of multiple stemmed co-dominant stem cluster.

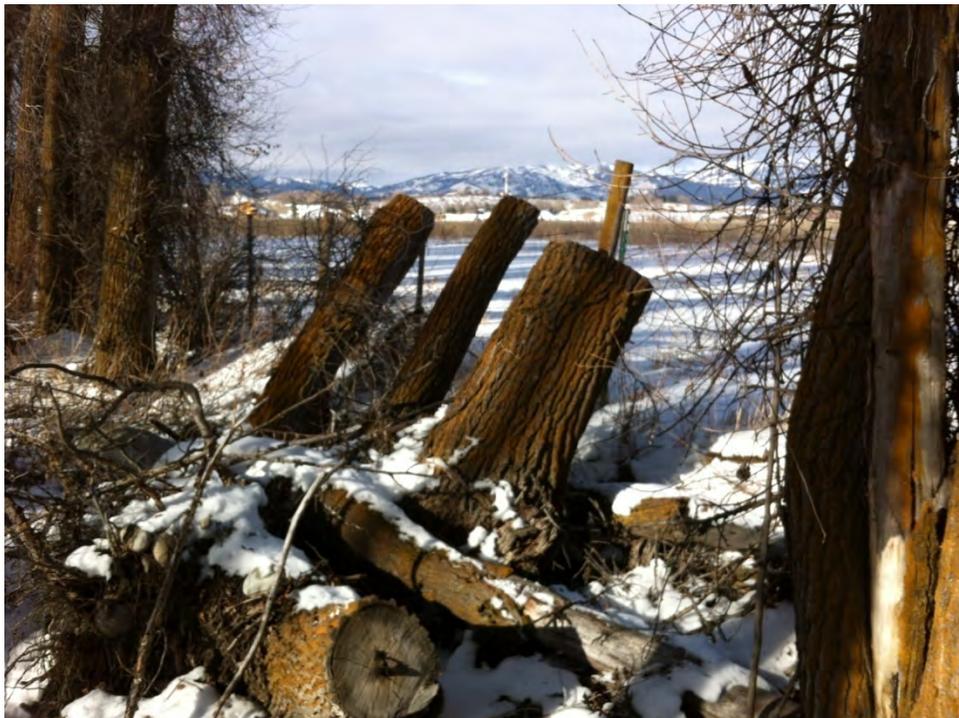
Photo #13: Co-dominant branching structure.

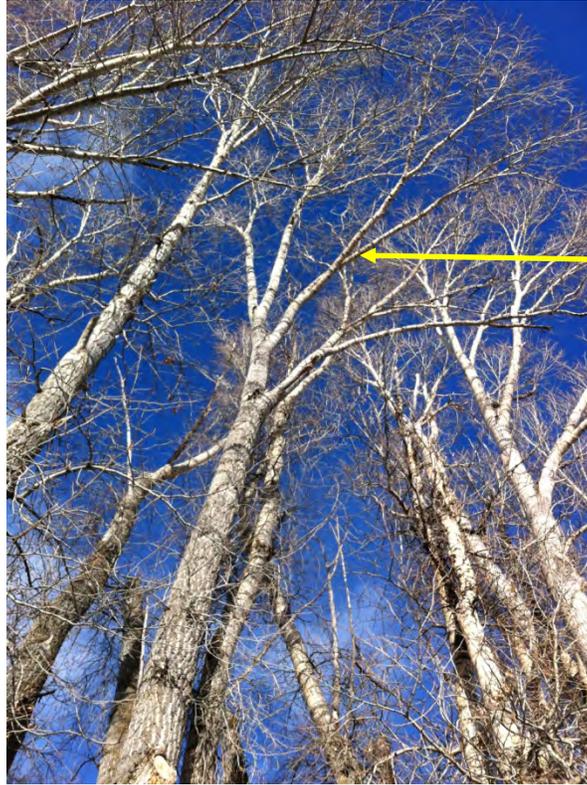
Photo #14: Co-dominant tops.

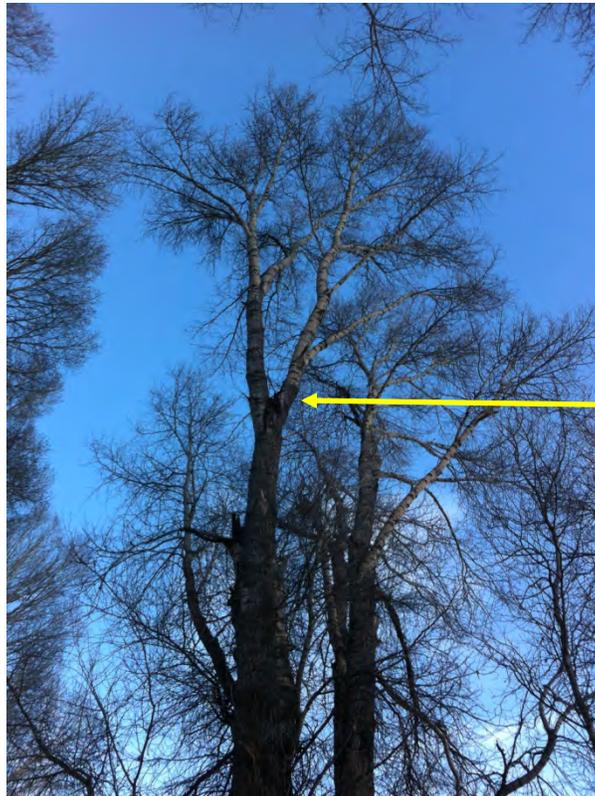
Photo #15: Evidence of past co-dominant top failure.

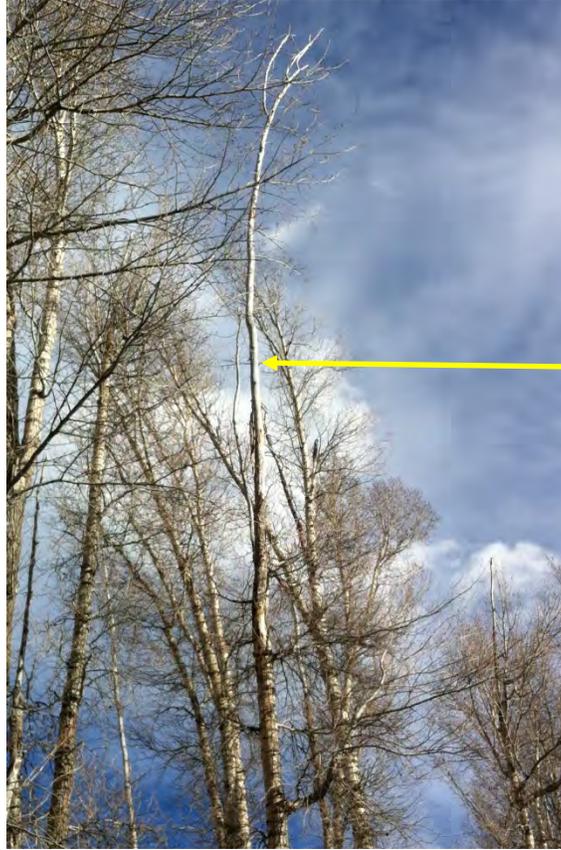
Photo #18: Subordinate trees and poor canopy development.
