### Concept Environmental Memo

**SUBJECT:** Teton Centennial Trail – Environmental Regulatory Considerations

**PROJECT:** FHAX0000-0220  
Idaho Teton Trail

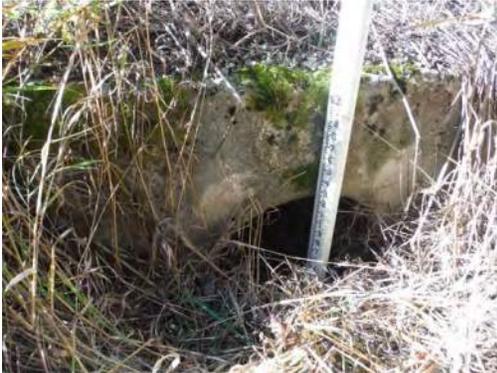
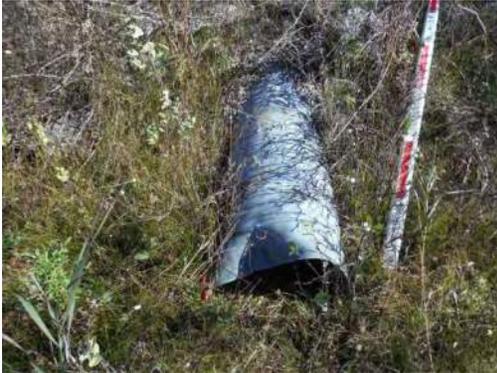
<p>Upstream</p>

MAP ID NUMBER	LOCATION	RESOURCE DESCRIPTION	NRHP ELIGIBILITY	PHOTOGRAPHS
1	<p>Old Jackson Highway Victor, Idaho vicinity</p> <p>UTM: 948094.5186, 691299.5224 948046.8738, 691271.0512</p>	<p>Pre-1961 steel CMP culvert Diameter: 18 inches Length: 56 feet Upstream concrete headwall</p>	<p>Recommended Not Eligible for listing in the NRHP as it lacks distinctive engineering qualities (Criterion C)</p>

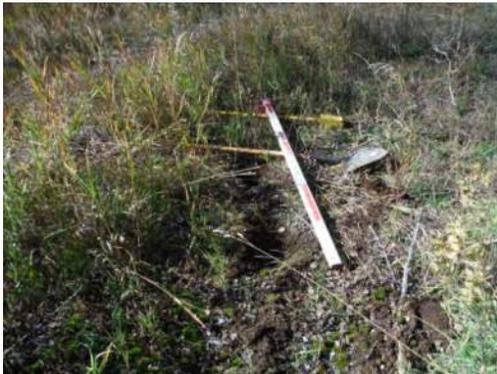
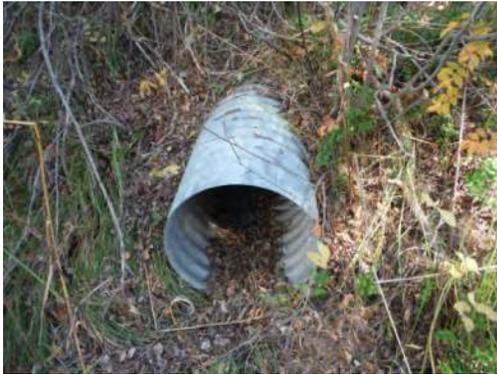
<p>Upstream</p>

MAP ID NUMBER	LOCATION	RESOURCE DESCRIPTION	NRHP ELIGIBILITY	PHOTOGRAPHS
2	<p>Old Jackson Highway Victor, Idaho vicinity</p> <p>UTM: 949025.3082, 690290.6669 949006.9308, 690255.7224</p>	<p>Pre-1961 steel CMP culvert Diameter: 18 inches Length: 40 feet (approx.) No headwall noted; upstream culvert buried</p>	<p>Recommended Not Eligible for listing in the NRHP as it lacks distinctive engineering qualities (Criterion C)</p>

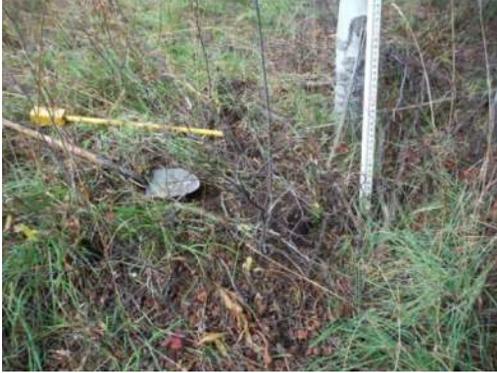
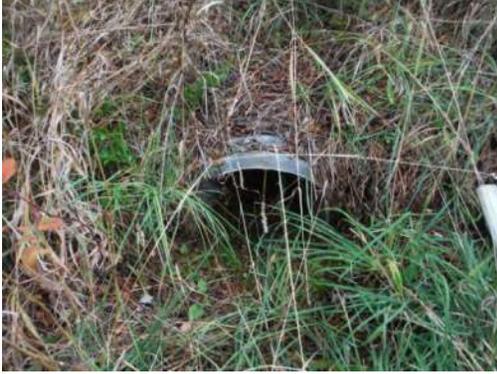
<p>Upstream</p>

MAP ID NUMBER	LOCATION	RESOURCE DESCRIPTION	NRHP ELIGIBILITY	PHOTOGRAPHS
3	<p>Old Jackson Highway Victor, Idaho vicinity</p> <p>UTM: 949282.4248, 689799.3558 949319.5770, 689799.5740</p>	<p>Pre-1961 steel CMP culvert Diameter: 18 feet Length: 40 feet (approx.) No headwalls noted; upstream culvert buried</p>	<p>Recommended Not Eligible for listing in the NRHP as it lacks distinctive engineering qualities (Criterion C)</p>

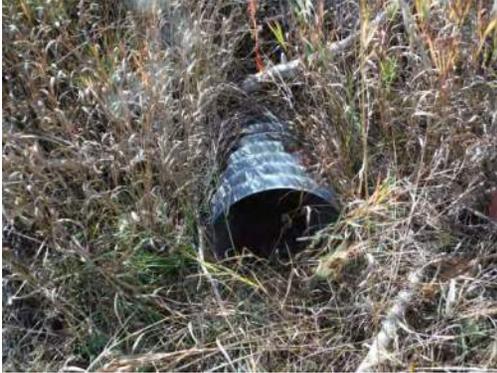
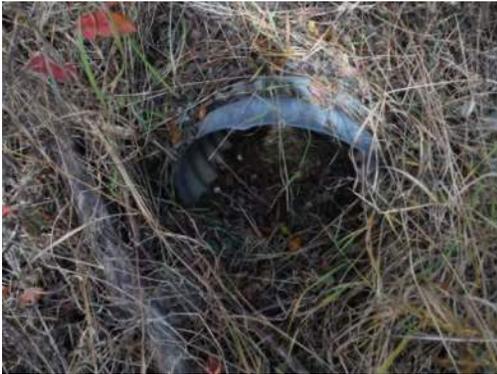
<p>Upstream</p>

MAP ID NUMBER	LOCATION	RESOURCE DESCRIPTION	NRHP ELIGIBILITY	PHOTOGRAPHS
4	<p>Old Jackson Highway Victor, Idaho vicinity</p> <p>UTM: 949799.9046, 689428.9581 949771.0515, 689385.9424</p>	<p>Pre-1961 steel CMP culvert Diameter: 18 inches Length: 52 feet (approx.) No headwalls noted</p>	<p>Recommended Not Eligible for listing in the NRHP as it lacks distinctive engineering qualities (Criterion C)</p>

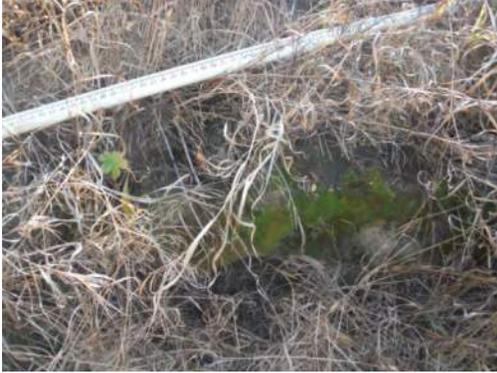
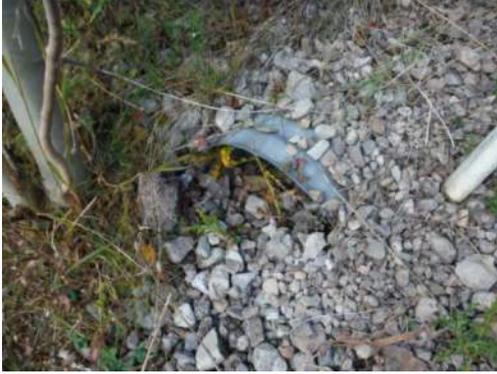
<p>Upstream</p>

MAP ID NUMBER	LOCATION	RESOURCE DESCRIPTION	NRHP ELIGIBILITY	PHOTOGRAPHS
5	<p>Old Jackson Highway Victor, Idaho vicinity</p> <p>UTM: 950190.0676, 688943.8549 950166.0329, 688883.2938</p>	<p>Pre-1961 steel CMP culvert Diameter: 18 inches Length: 65 feet (approx.) Upstream headwall partially buried, appears to be concrete</p>	<p>Recommended Not Eligible for listing in the NRHP as it lacks distinctive engineering qualities (Criterion C)</p>

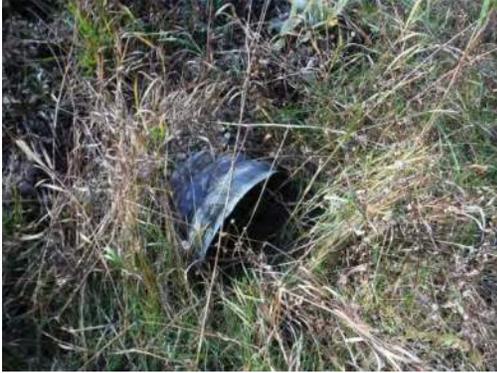
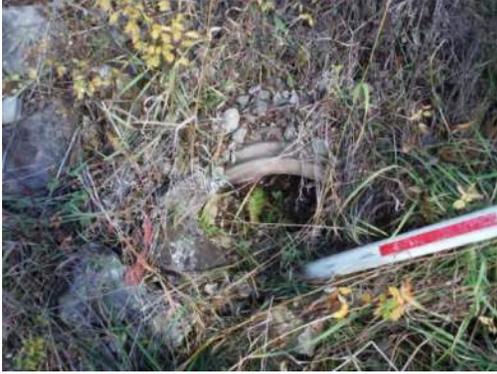
<p>Upstream</p>

MAP ID NUMBER	LOCATION	RESOURCE DESCRIPTION	NRHP ELIGIBILITY	PHOTOGRAPHS
6	<p>Old Jackson Highway Victor, Idaho vicinity</p> <p>UTM: 950528.6048, 688574.3750 950478.8443, 688548.8962</p>	<p>Pre-1961 steel CMP culvert Diameter: 18 inches Length: 57 feet (approx.) No visible headwalls</p>	<p>Recommended Not Eligible for listing in the NRHP as it lacks distinctive engineering qualities (Criterion C)</p>

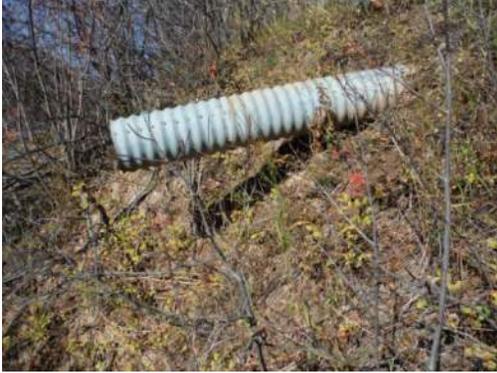
MAP ID NUMBER	LOCATION	RESOURCE DESCRIPTION	NRHP ELIGIBILITY	PHOTOGRAPHS
7	<p>Old Jackson Highway Victor, Idaho vicinity</p> <p>UTM: 950943.5476, 688173.2861 950943.6592, 688168.0938</p>	<p>Pre-1961 steel CMP culvert Diameter: 24 inches Length: 6 feet (approx.) No concrete headwalls</p>	<p>Recommended Not Eligible for listing in the NRHP as it lacks distinctive engineering qualities (Criterion C)</p>

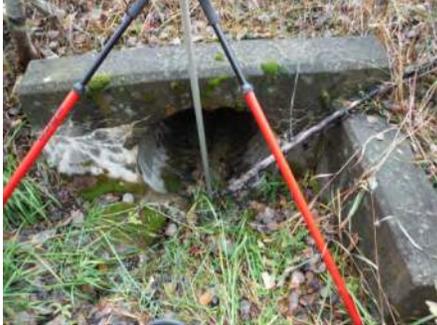
<p>Upstream</p> <p>No Downstream Photo Available</p>

<p>Downstream</p> <p>No Upstream Photo Available</p>
8	<p>Old Jackson Highway Victor, Idaho vicinity</p> <p>UTM: 951606.4790, 687686.3518 951542.2002, 687609.7474</p>	<p>Pre-1961 steel CMP culvert Diameter: 24 inches Length: 100 feet (approx.) Upstream concrete headwall and one wing wall</p>	<p>Recommended Not Eligible for listing in the NRHP as it lacks distinctive engineering qualities (Criterion C)</p>

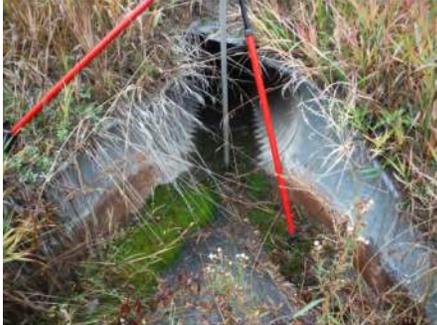
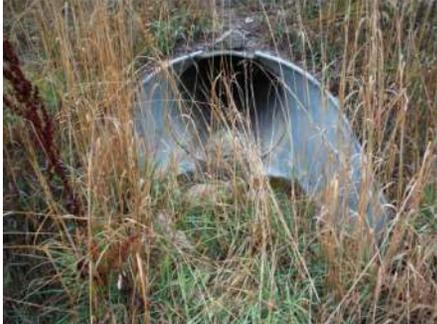
<p>Upstream</p>

MAP ID NUMBER	LOCATION	RESOURCE DESCRIPTION	NRHP ELIGIBILITY	PHOTOGRAPHS
11	<p>Old Jackson Highway Wyoming</p> <p>UTM: 954924.5749, 685394.8216 954905.2687, 685338.6576</p>	<p>Pre-1961 steel CMP culvert Diameter: 30 inches Length: 60 feet (approx.) No concrete headwalls; metal flared end sections</p>	<p>Recommended Not Eligible for listing in the NRHP as it lacks distinctive engineering qualities (Criterion C)</p>

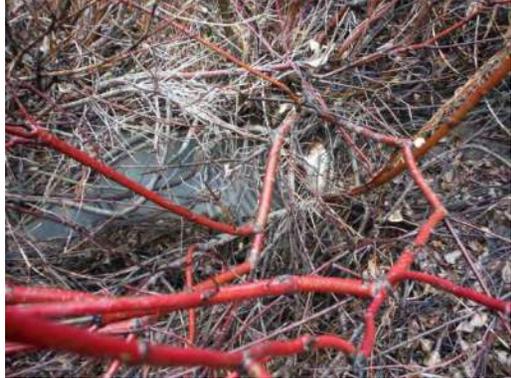
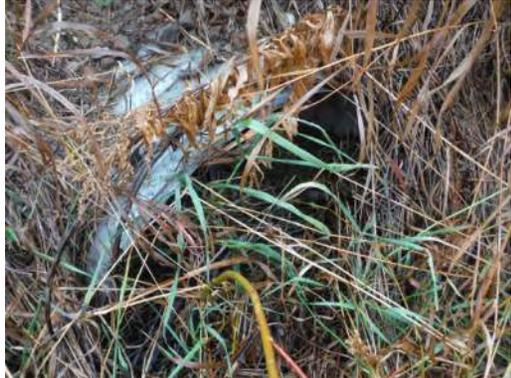
<p>Upstream</p>

MAP ID NUMBER	LOCATION	RESOURCE DESCRIPTION	NRHP ELIGIBILITY	PHOTOGRAPHS
12	<p>Old Jackson Highway Wyoming</p> <p>UTM: 954882.9467, 685276.3209 954873.0891, 685209.6741</p>	<p>Pre-1961 steel CMP culvert Diameter: 30 inches Length: 68 feet (approx.) No concrete headwalls; metal flared end sections</p>	<p>Recommended Not Eligible for listing in the NRHP as it is lacking in distinctive engineering qualities (Criterion C)</p>
