Subject: Pre-Construction Notification –South Park Loop Pathway Connector Project

DRAWING NO 1 OF 2	JOB NO 15-257-02	JOB TITLE SOUTH PARK LOOP CONNECTOR PATHWAY PROJECT TETON COUNTY, WY	DRAWING TITLE WETLAND ENCROACHMENT EXHIBIT	DATE 3/15/2016	SURVEYED	ENGINEERED	DRAWN	CHECKED	APPROVED
				REV.	NE	DD	AL	DD	DD

**WETLAND DELINEATION REPORT
SOUTH PARK LOOP PATHWAY PROJECT
JACKSON, TETON COUNTY WYOMING**

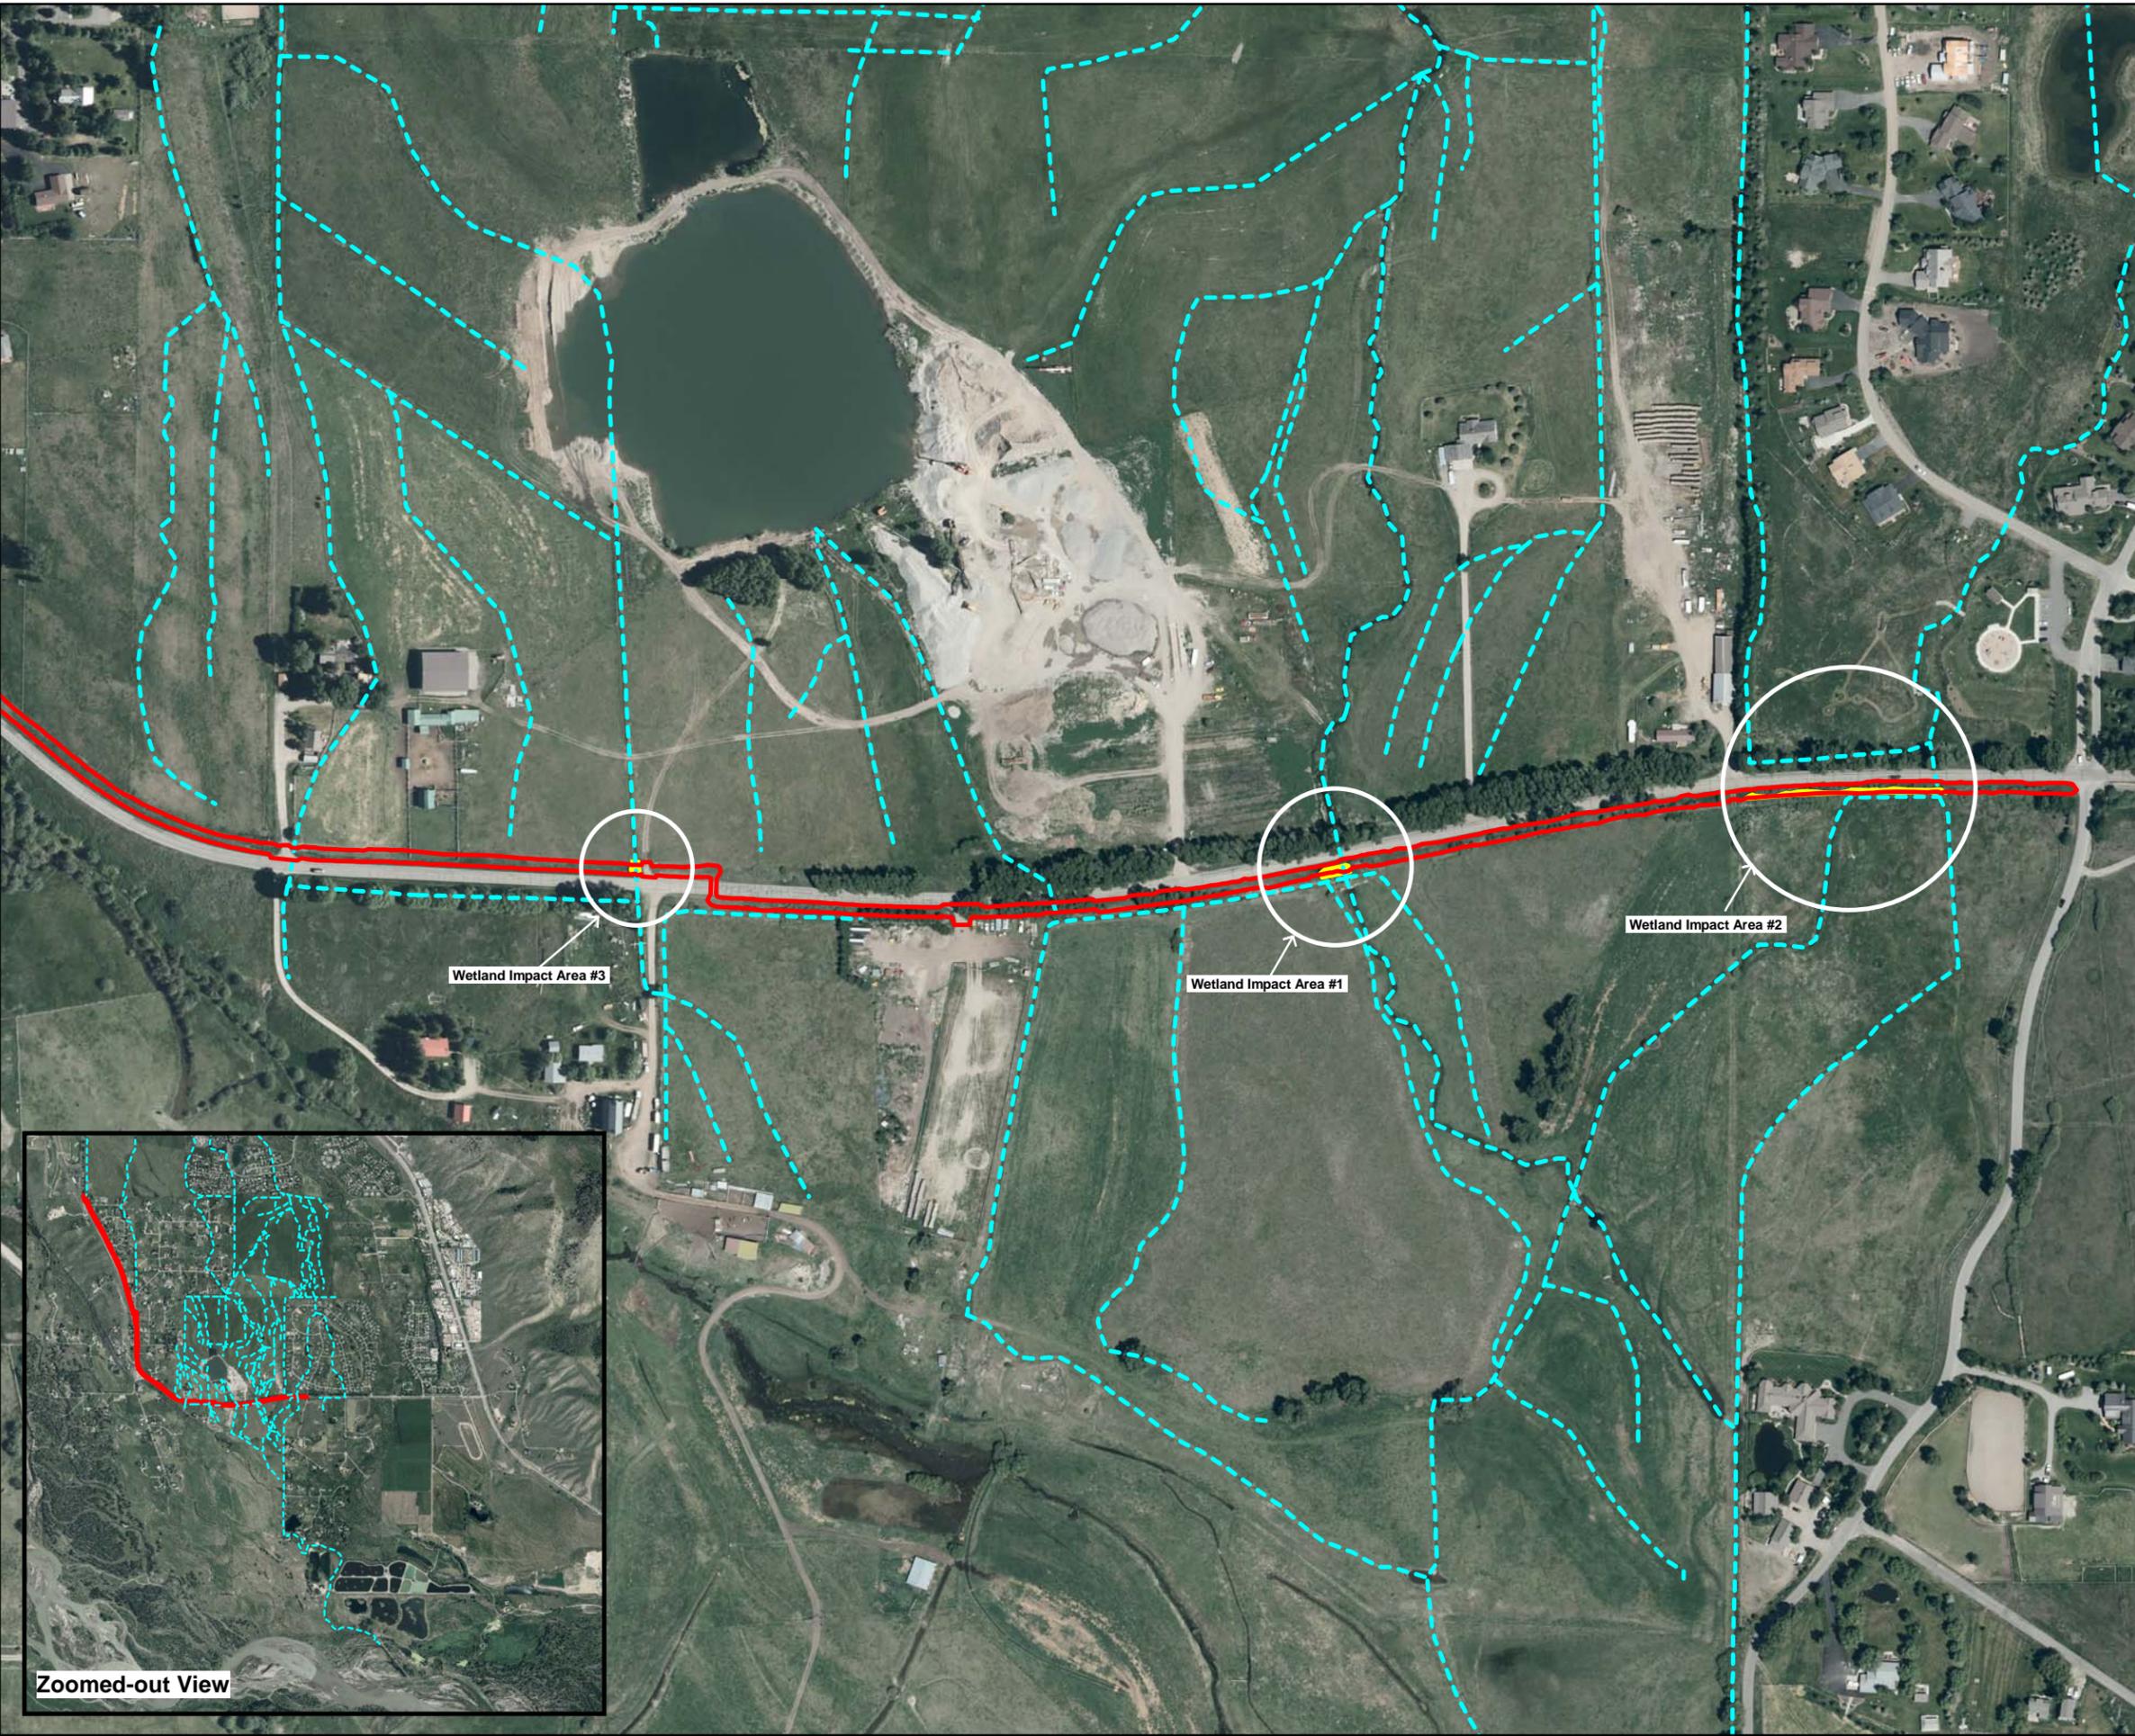
Exhibit 3
Proposed wetland impact areas within the South
Park Loop Pathway Connector project area,
Teton County, Wyoming.

Wetland Impact Area #1 - 540 sf (32 cy of fill)
Wetland Impact Area #2 - 1,980 sf (98 cy of fill)
Wetland Impact Area #3 - 290 sf (9 cy of fill)

Total Wetland Impact - 2,810 sf (139 cy of fill)

Approximately 139 cubic yards of fill will be placed in wetlands to construct the pathway segment, resulting in 2,810 sq ft of wetland impact (Table 1; Attachment 1-Exhibits 3 and 4). In addition, it will be necessary to extend the existing culverts under South Park Loop for 8 irrigation ditch crossings, which will result in approximately 435 sq ft of impact to these ditches. Fill will be comprised of pit run, culverts, crushed aggregate, and asphalt (see typical section provided by Nelson Engineering presented in Attachment 1-Exhibit 5). Silt fence will be installed and best management practices will be utilized to prevent sediment from moving off site and protect water quality in adjacent waterbodies. Pathway construction will involve the use of heavy equipment, including an excavator, loader, drum roller, and haul trucks. All temporary impacts will be fully reclaimed and revegetated upon project completion.

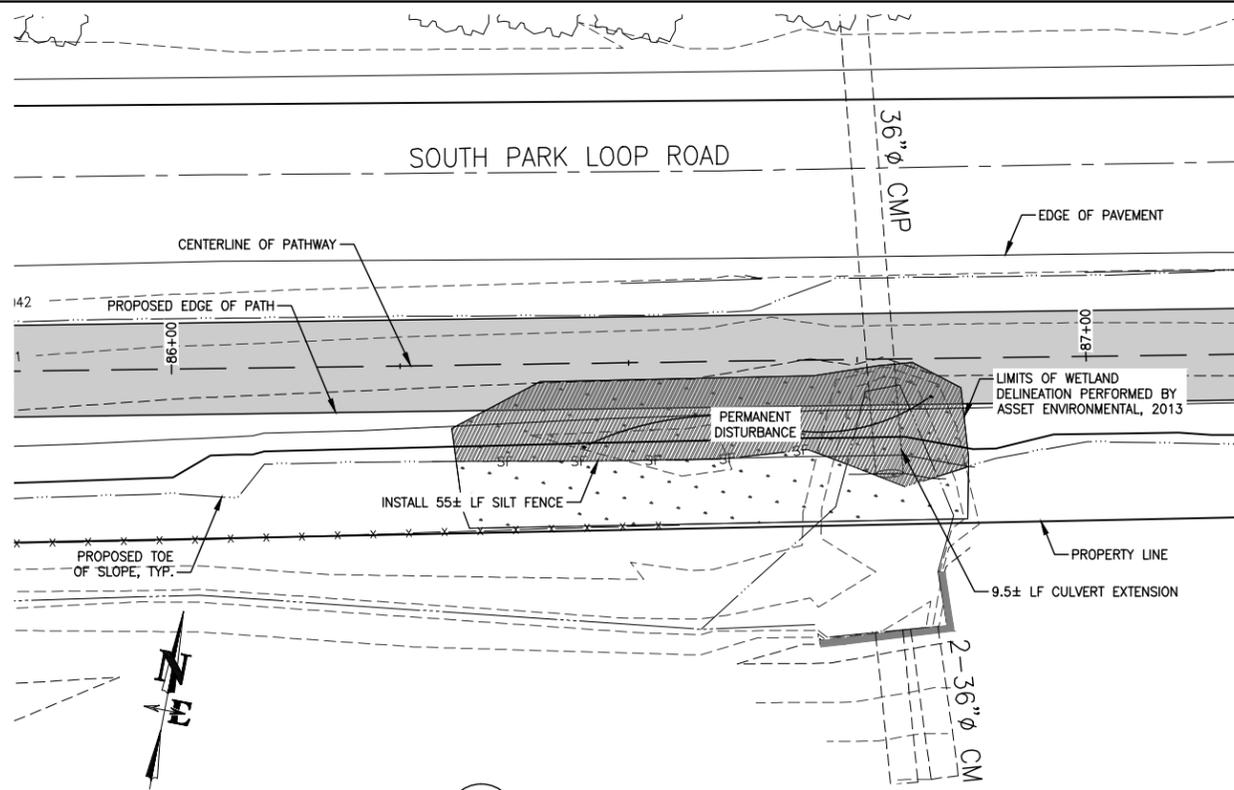
1 WETLAND IMPACT AREA 1
 EX Scale: 1"=20' (11x17)

AREA OF PERMANENT DISTURBANCE AREA 1	=	540	SQUARE FEET
VOLUME OF FILL AREA 1	=	32	CUBIC YARDS
LENGTH OF SILT FENCE AREA 1	=	55	LINEAR FEET
(1) 9.5'x36"Ø CMP CULVERT EXTENSION			
AREA OF PERMANENT DISTURBANCE AREA 2	=	1980	SQUARE FEET
VOLUME OF FILL AREA 2	=	98	CUBIC YARDS
LENGTH OF SILT FENCE AREA 2	=	375	LINEAR FEET
(2) 6'x24"Ø CMP CULVERT EXTENSIONS			
(1) 5'x18"Ø CMP CULVERT EXTENSION

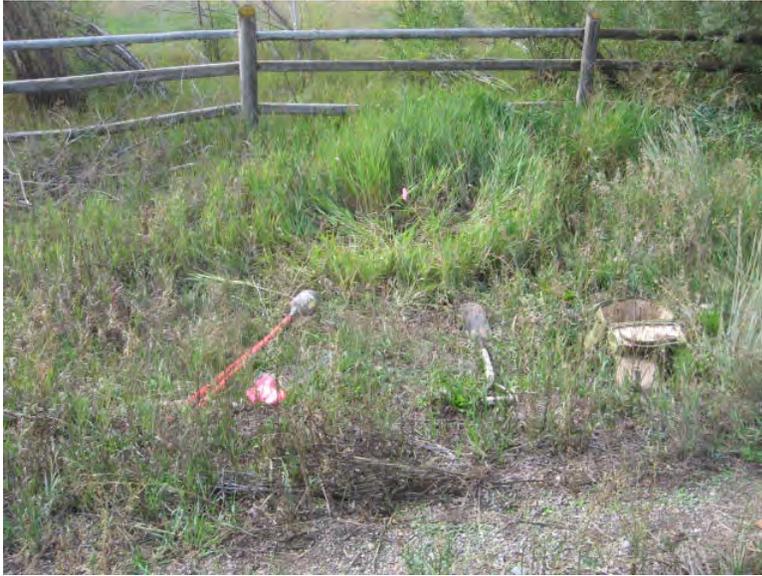
P1. View of Sample Pit #1 facing south toward private fenceline/edge of ROW.

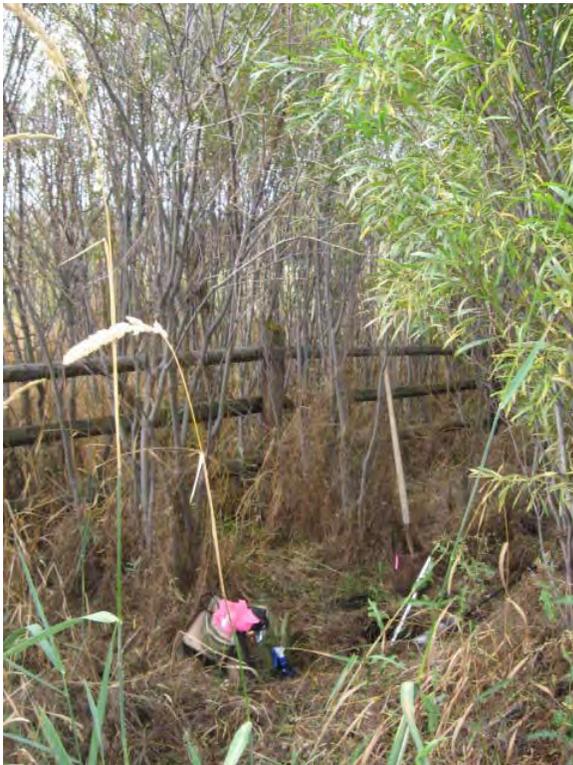
P2. View of Sample Pit #2 facing south-southwest toward fenceline/edge of ROW.

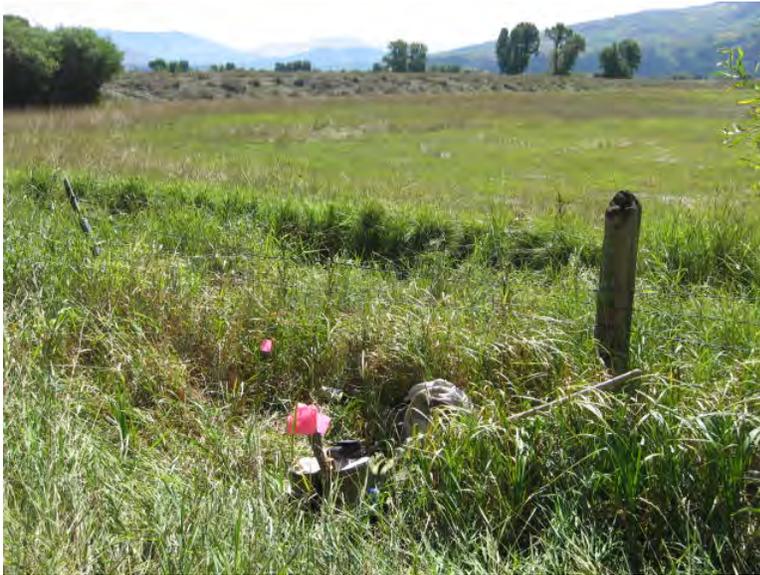
P3. View of Sample Pit #3 facing south-southeast toward fenceline/edge of ROW. Active, flowing, irrigation ditch located just on opposite side of fence.

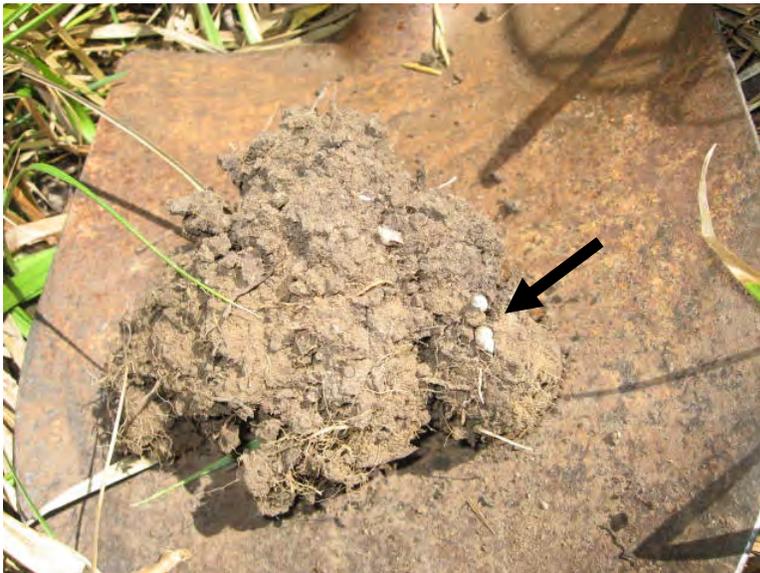
P4. View of soil from Sample Pit #3. Note presence of aquatic invertebrates throughout.

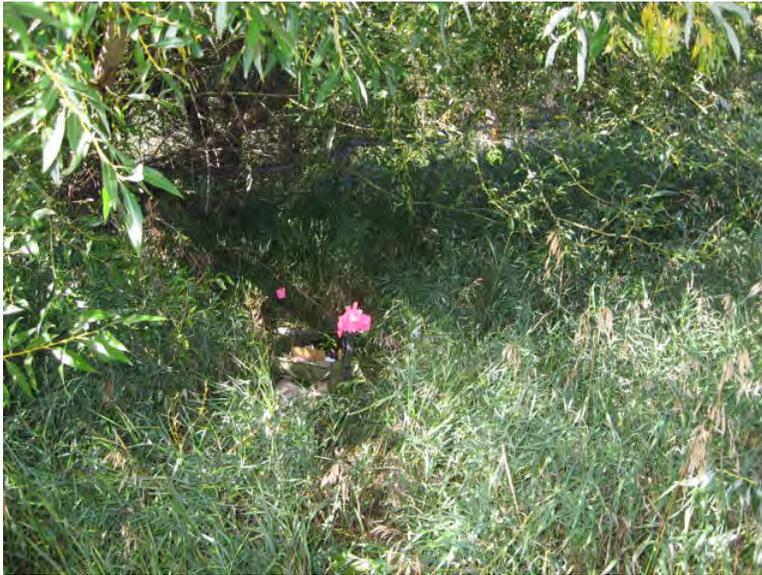
P5. View of Sample Pit #4 facing south.

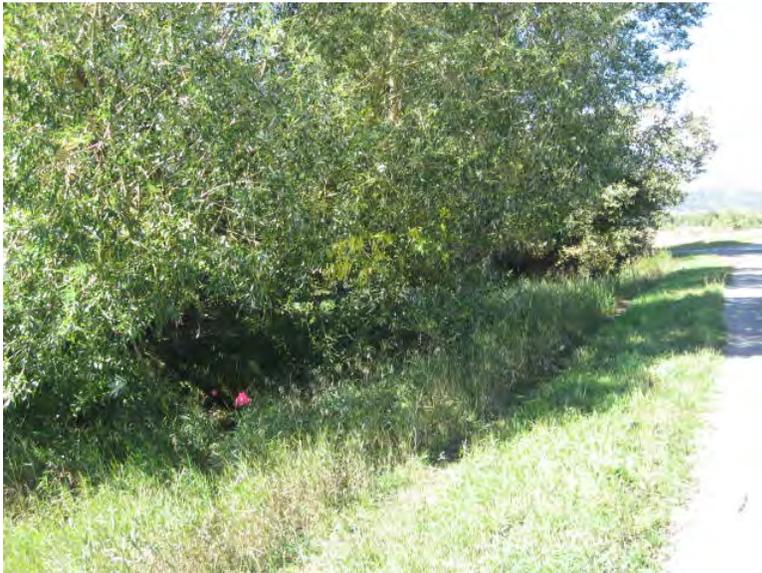
P6. Another view of Sample Pit #4 facing west.

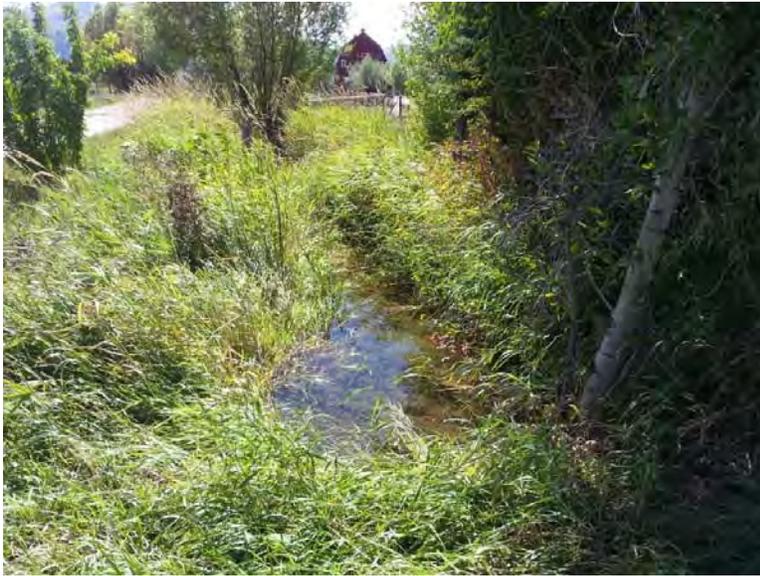
P7. View of western-most irrigation ditch/culvert crossing, facing south. Private drive off to the left hand side of the picture.

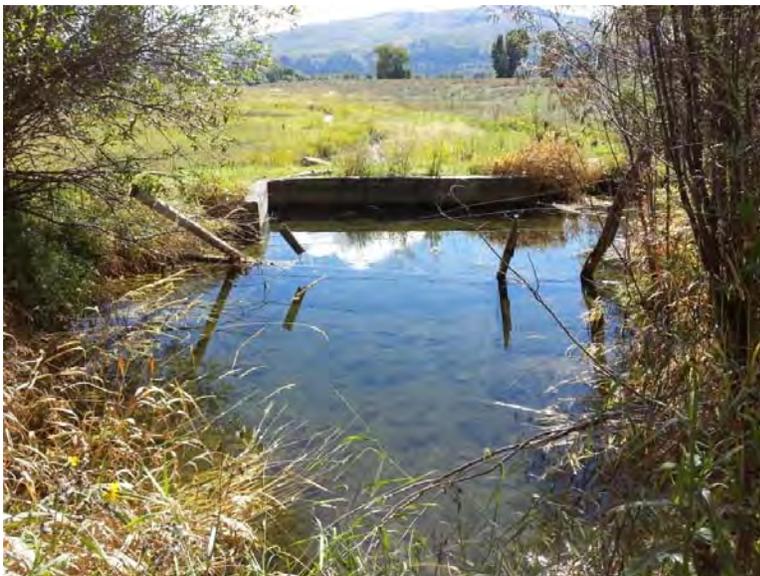
P8. View of another irrigation ditch/culvert crossing east of the crossing in picture #7.
