Project No: TAP-TL13003 South Park
Pathway Connector Project
South Park Loop Pathway
South Park Loop, Jackson
Teton County
Pathway Construction

THIS DOCUMENT IS A DRAFT ENVIRONMENTAL FIELD REVIEW REPORT

**WETLAND DELINEATION REPORT
SOUTH PARK LOOP PATHWAY PROJECT
JACKSON, TETON COUNTY WYOMING**

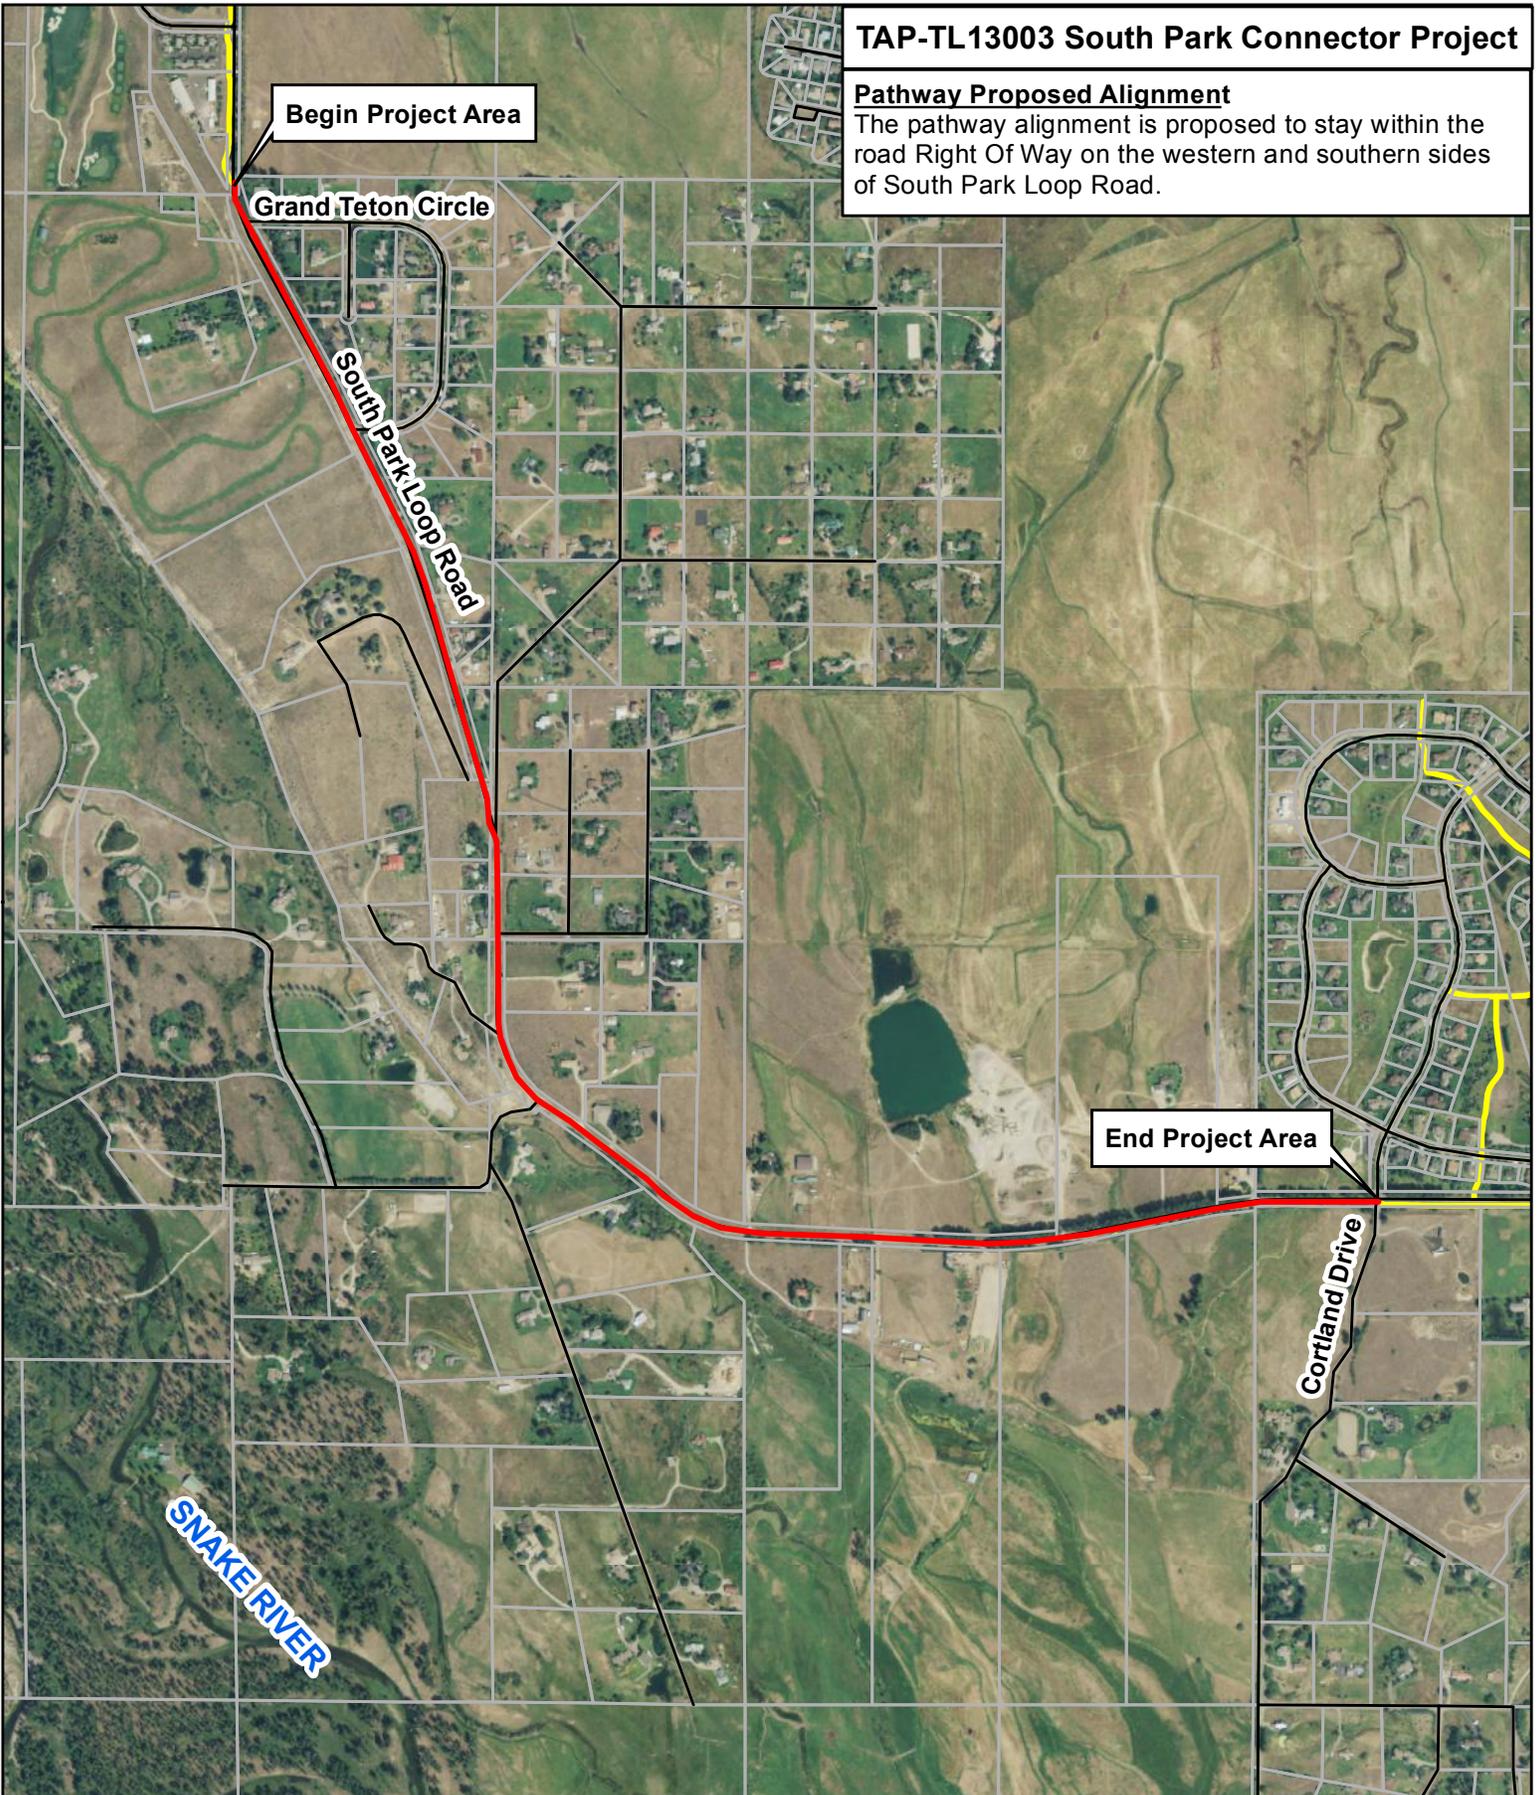
FIGURE 2:
**Proposed
Project**
March 3, 2015

The pathway alignment is proposed to stay within the road Right Of Way on the western and southern sides of South Park Loop Road.

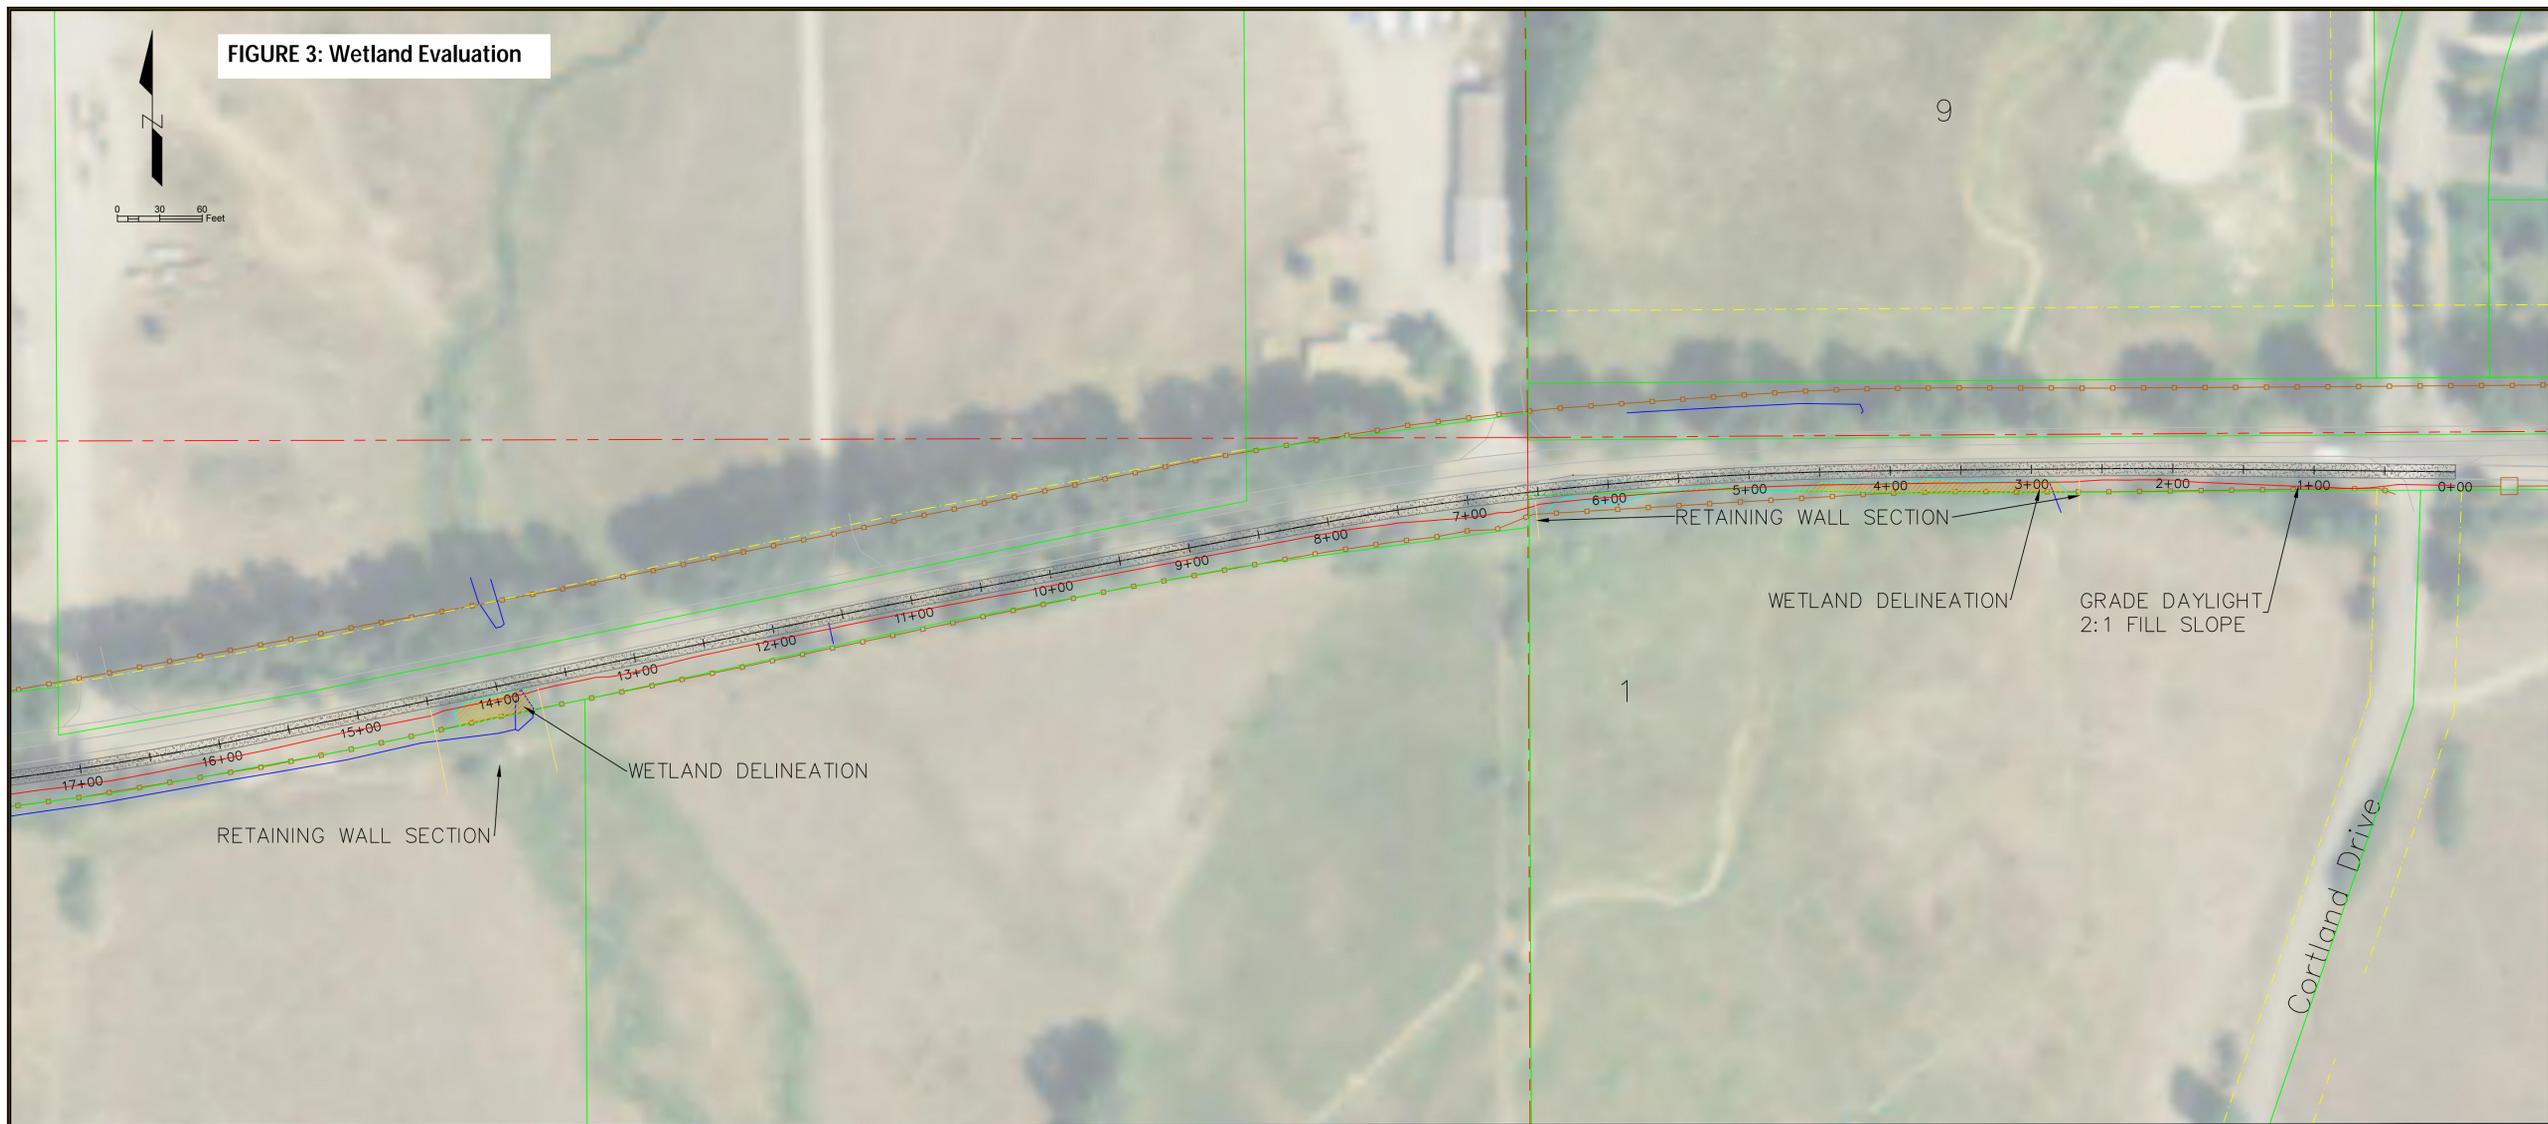
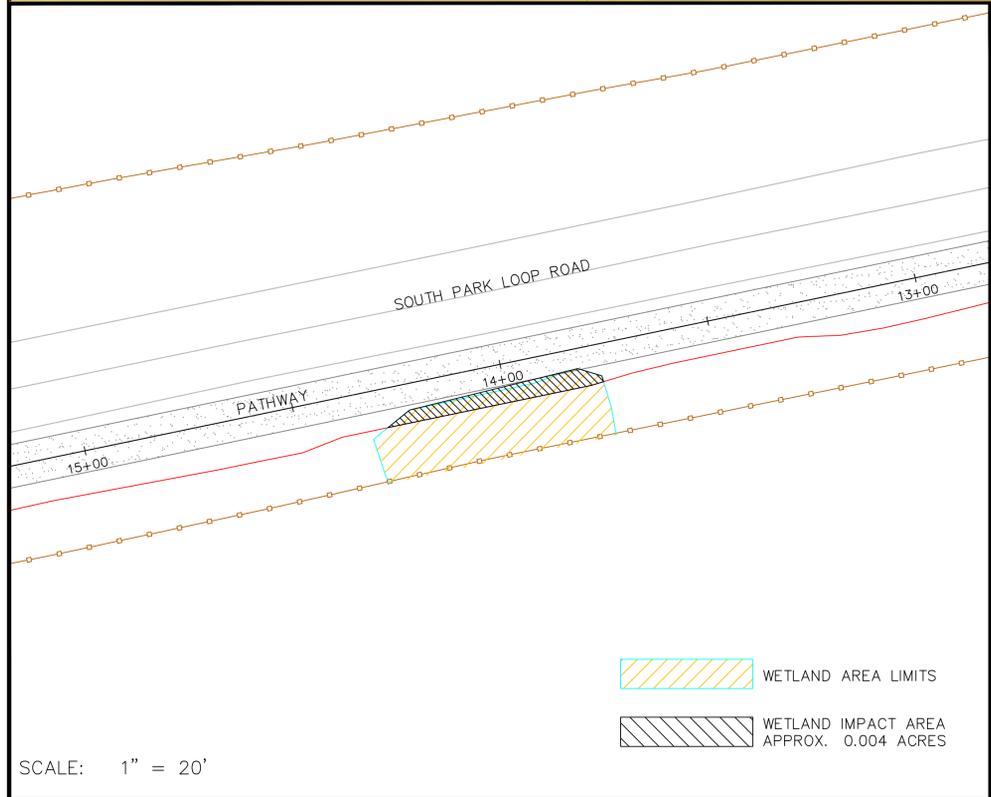
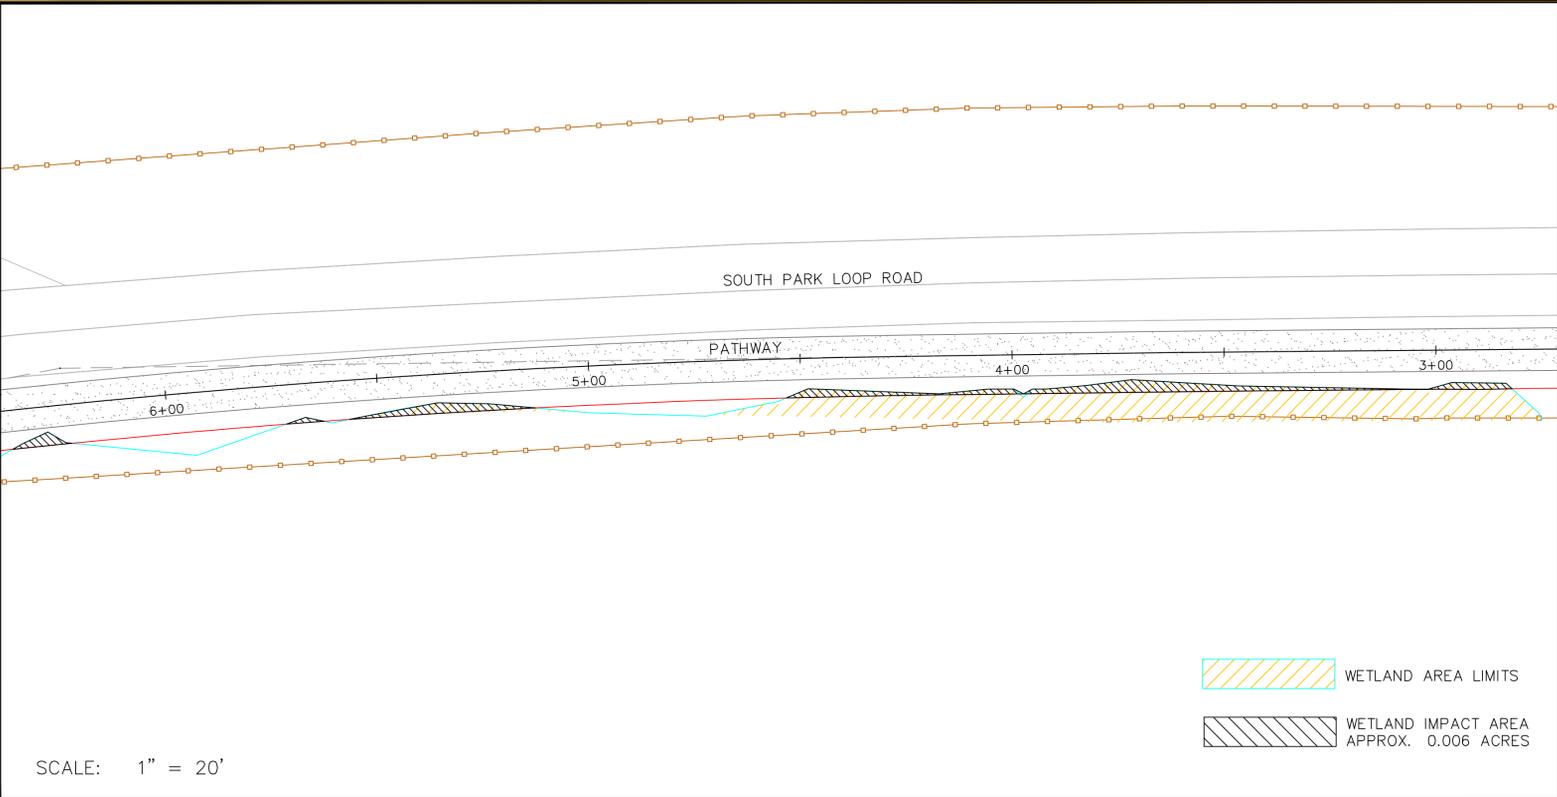
FIGURE 3: Wetland Evaluation

PROJECT:	SOUTH PARK LOOP ROAD PATHWAY
DESCRIPTION:	WETLAND EVALUATION
LOCATION:	SOUTH PARK LOOP ROAD
S/D:	N/A
LOT #:	N/A
DRAWN BY:	DEG
DATE:	AUGUST 12, 2015
CKD BY:	BS
DATE:	AUGUST 12, 2015
PATH:	r:\splrpathway.dwg
SHEET NUMBER:	1

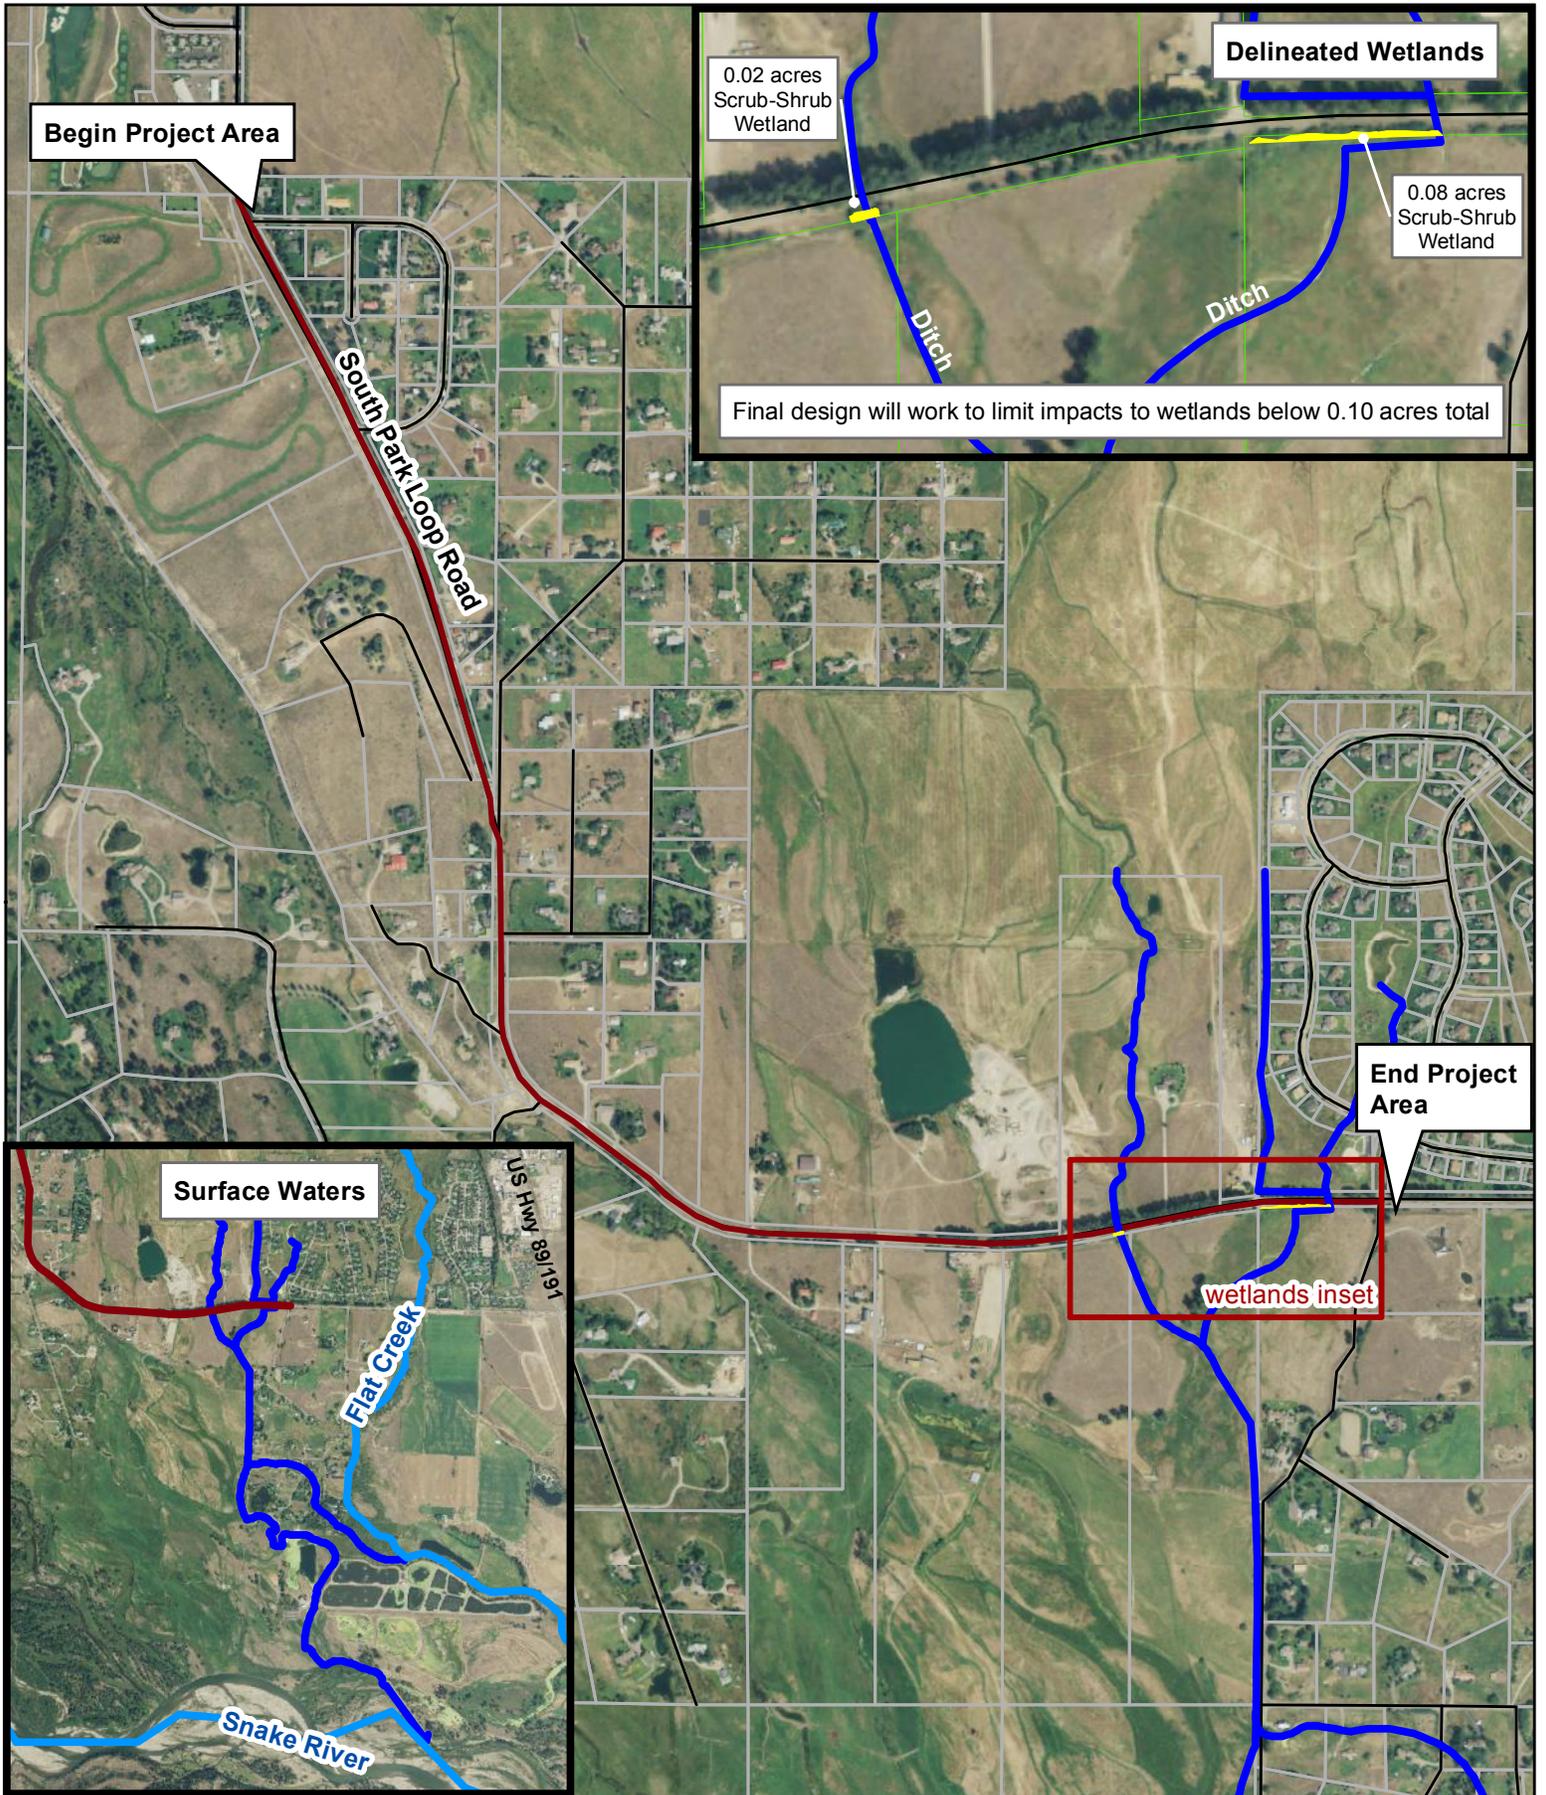
FIGURE 1:
**Project Area
& Wetlands
Delineation**
January 26, 2015

**Jackson Hole
Community
Pathways**
**South Park
Loop Rd**
Teton County, WY

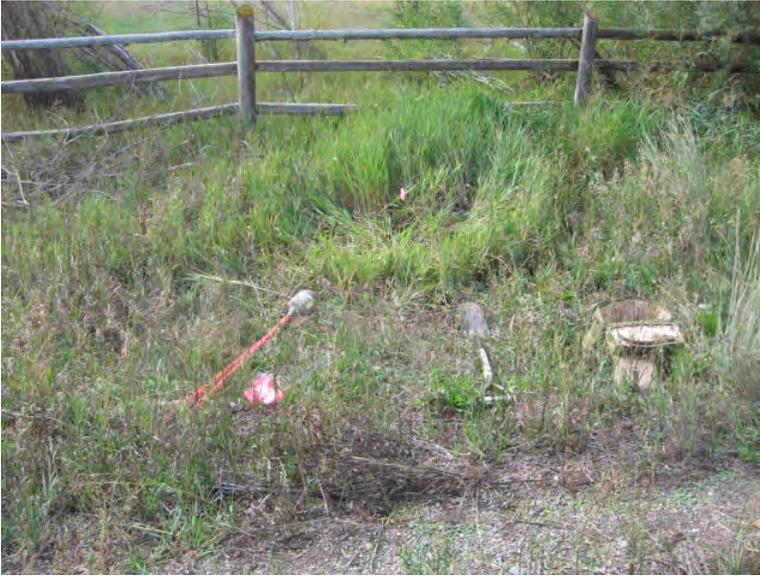
P1. View of Sample Pit #1 facing south toward private fenceline/edge of ROW.

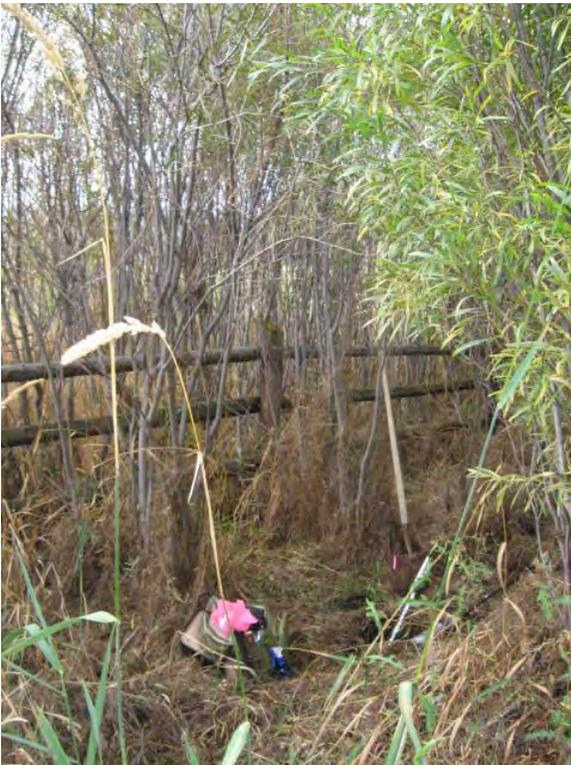
P2. View of Sample Pit #2 facing south-southwest toward fenceline/edge of ROW.

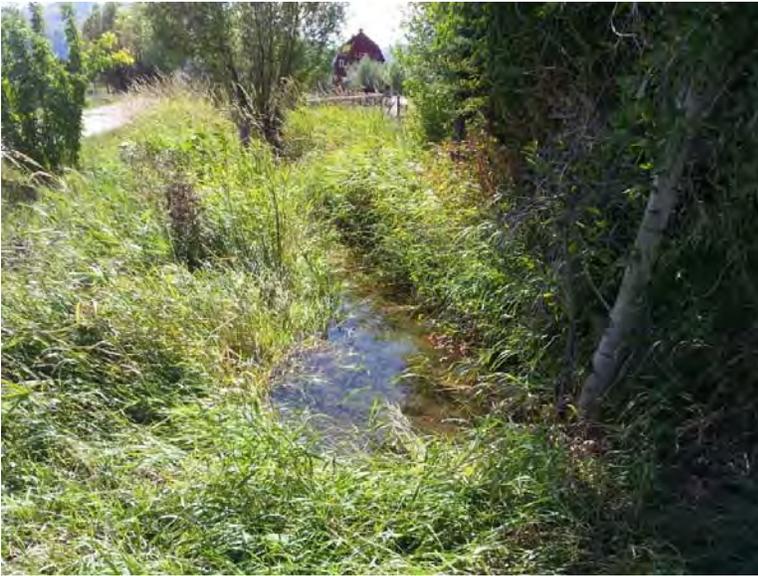
P7. View of western-most irrigation ditch/culvert crossing, facing south. Private drive off to the left hand side of the picture.

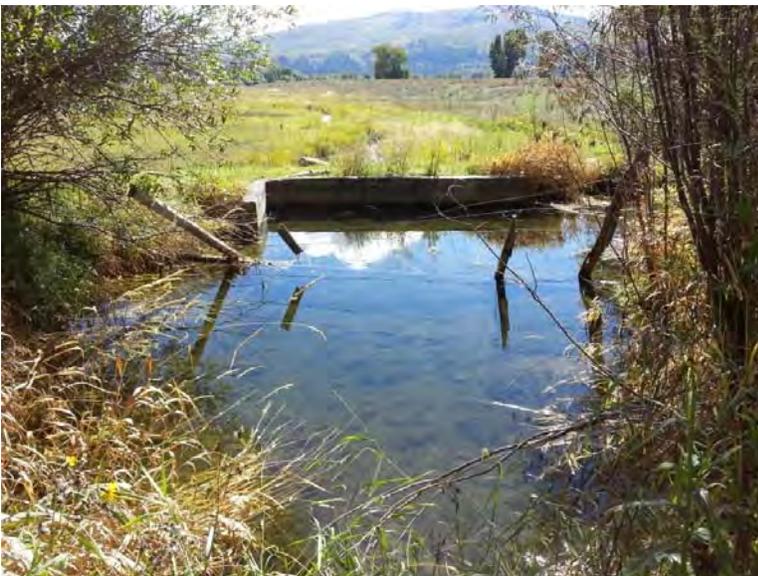
P8. View of another irrigation ditch/culvert crossing east of the crossing in picture #7.

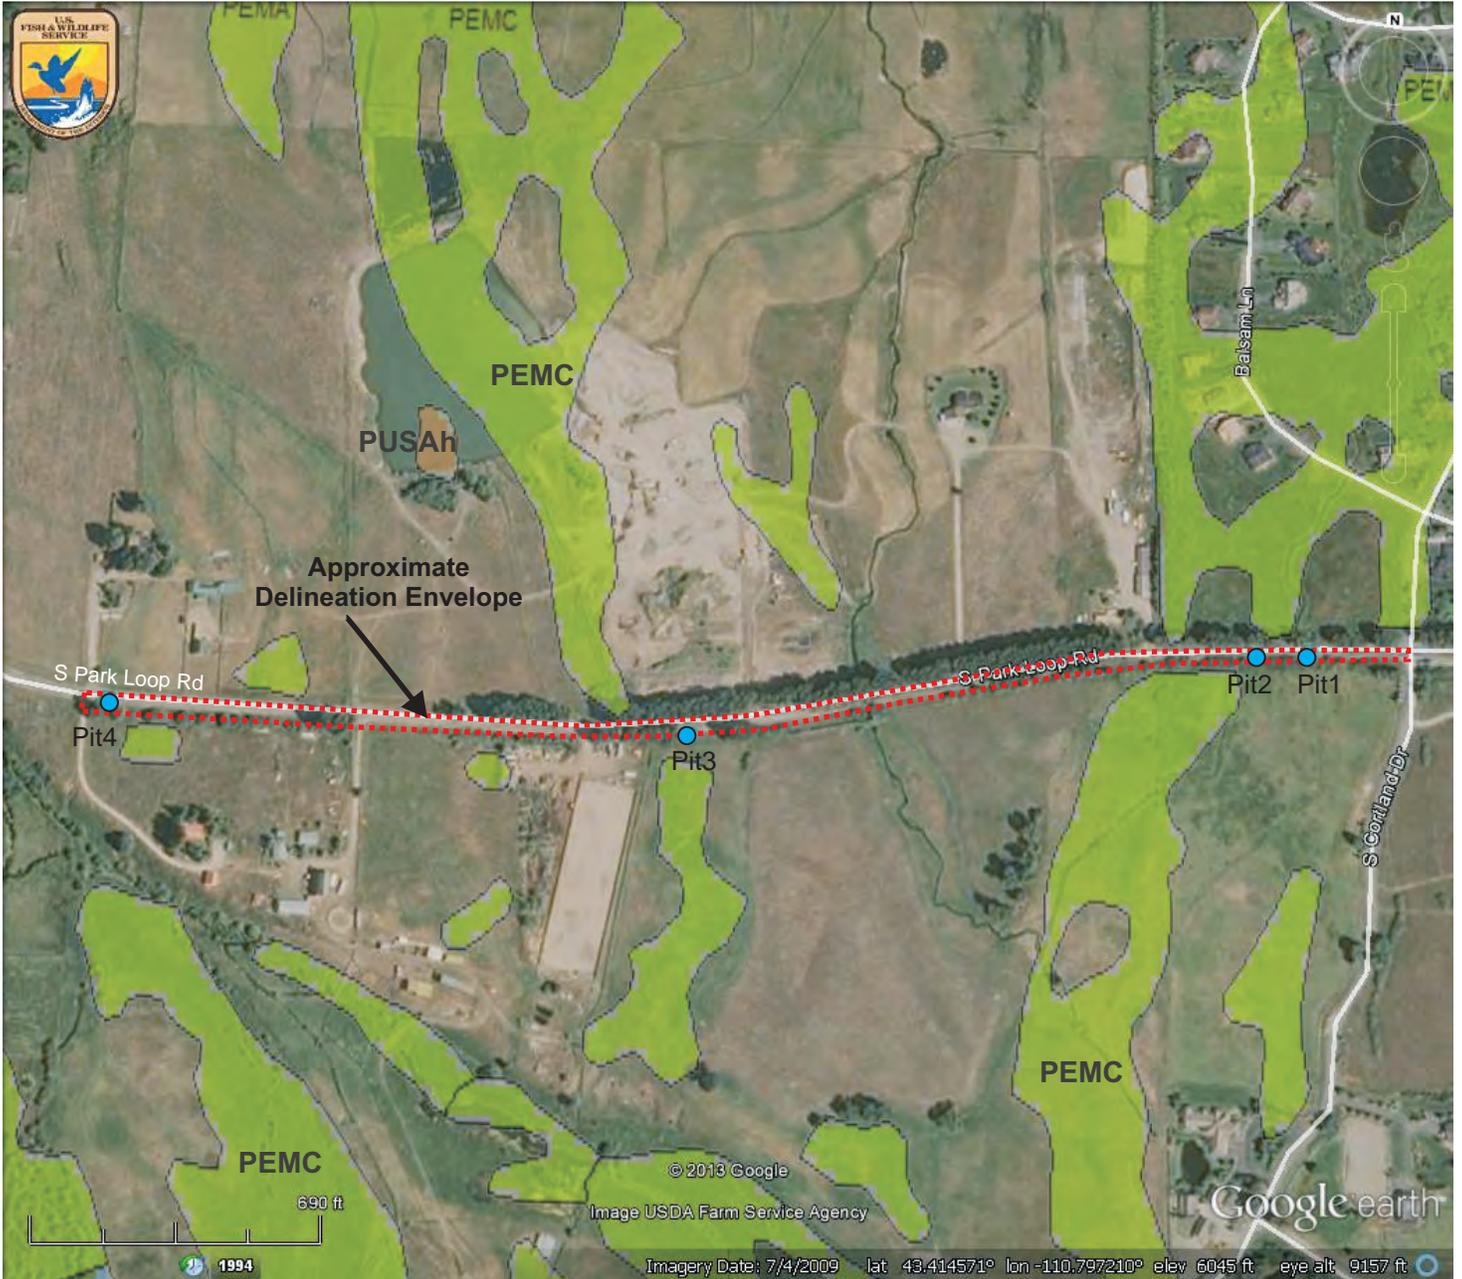
See Wetland Classification Codes in Appendix C of the Wetland Delineation Report for Wetland Types shown here.

COPIED FROM GOOGLE EARTH WITH THE FOLLOWING LAYERS:
 1. USFWS NATIONAL WETLAND INVENTORY DATA
 2. AERIAL IMAGERY (4 JULY 2009), USDA FARM SERVICE AGENCY

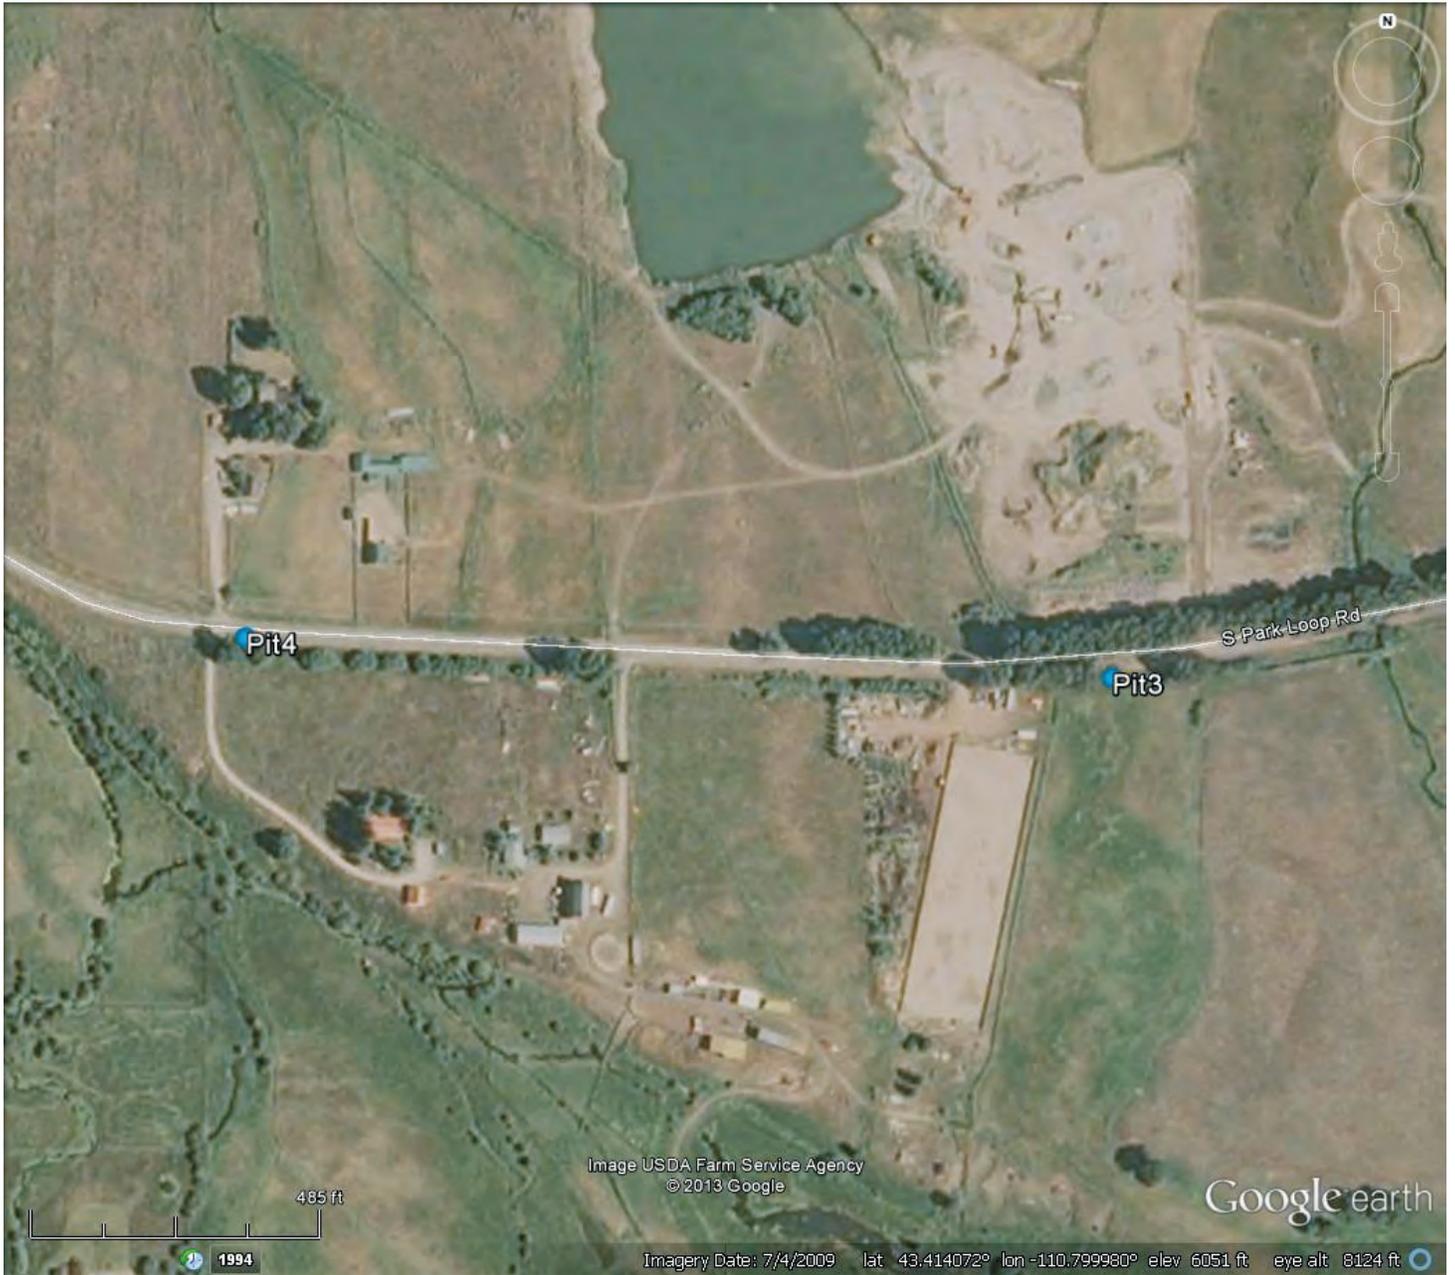
COPIED FROM GOOGLE EARTH USDA FARM SERVICE AGENCY
AERIAL IMAGERY TAKEN 4 JULY 2009

Using standard delineation procedures described in the Regional Supplement to the 1987 Army Corps of Engineers Wetland Delineation Manual (USACE 1987): Western Mountains, Valleys and Coast Region (USACE 2010), Asset conducted a routine small area wetland delineation of the project area with an on-site inspection on 17 and 19 September 2013 (between rain storms typical for the time of year). See Figures 3 and 4 for a reference of sample point locations.

Four sample points were examined during the survey. A summary of each sample point is given below and the sites are identified in Figures 3 and 4. Photographs of each sample point are included in Section 6.0 and the wetland delineation forms for each sample point are included in Appendix B. All sample points were located south of South Park Loop Drive and north of the fence line (which designates the edge of the transportation ROW). Additionally, active irrigation ditch/culvert crossings with ponded and flowing water were thickly vegetated with predominantly facultative wetland species and, as such, their fringe edges appear to possibly qualify as wetland. See pictures P7 and P8 in Section 6.0 of this report.
