Attachment 1
Location and topography of the Path 22 West
project area, Teton County, Wyoming.

Attachment 2
 2011 aerial photograph depicting alignment and
 land ownership of the Path 22 West project area,
 Teton County, Wyoming.

Attachment 3
 2011 aerial photograph depicting surface water
 features within the Path 22 West project area,
 Teton County, Wyoming.

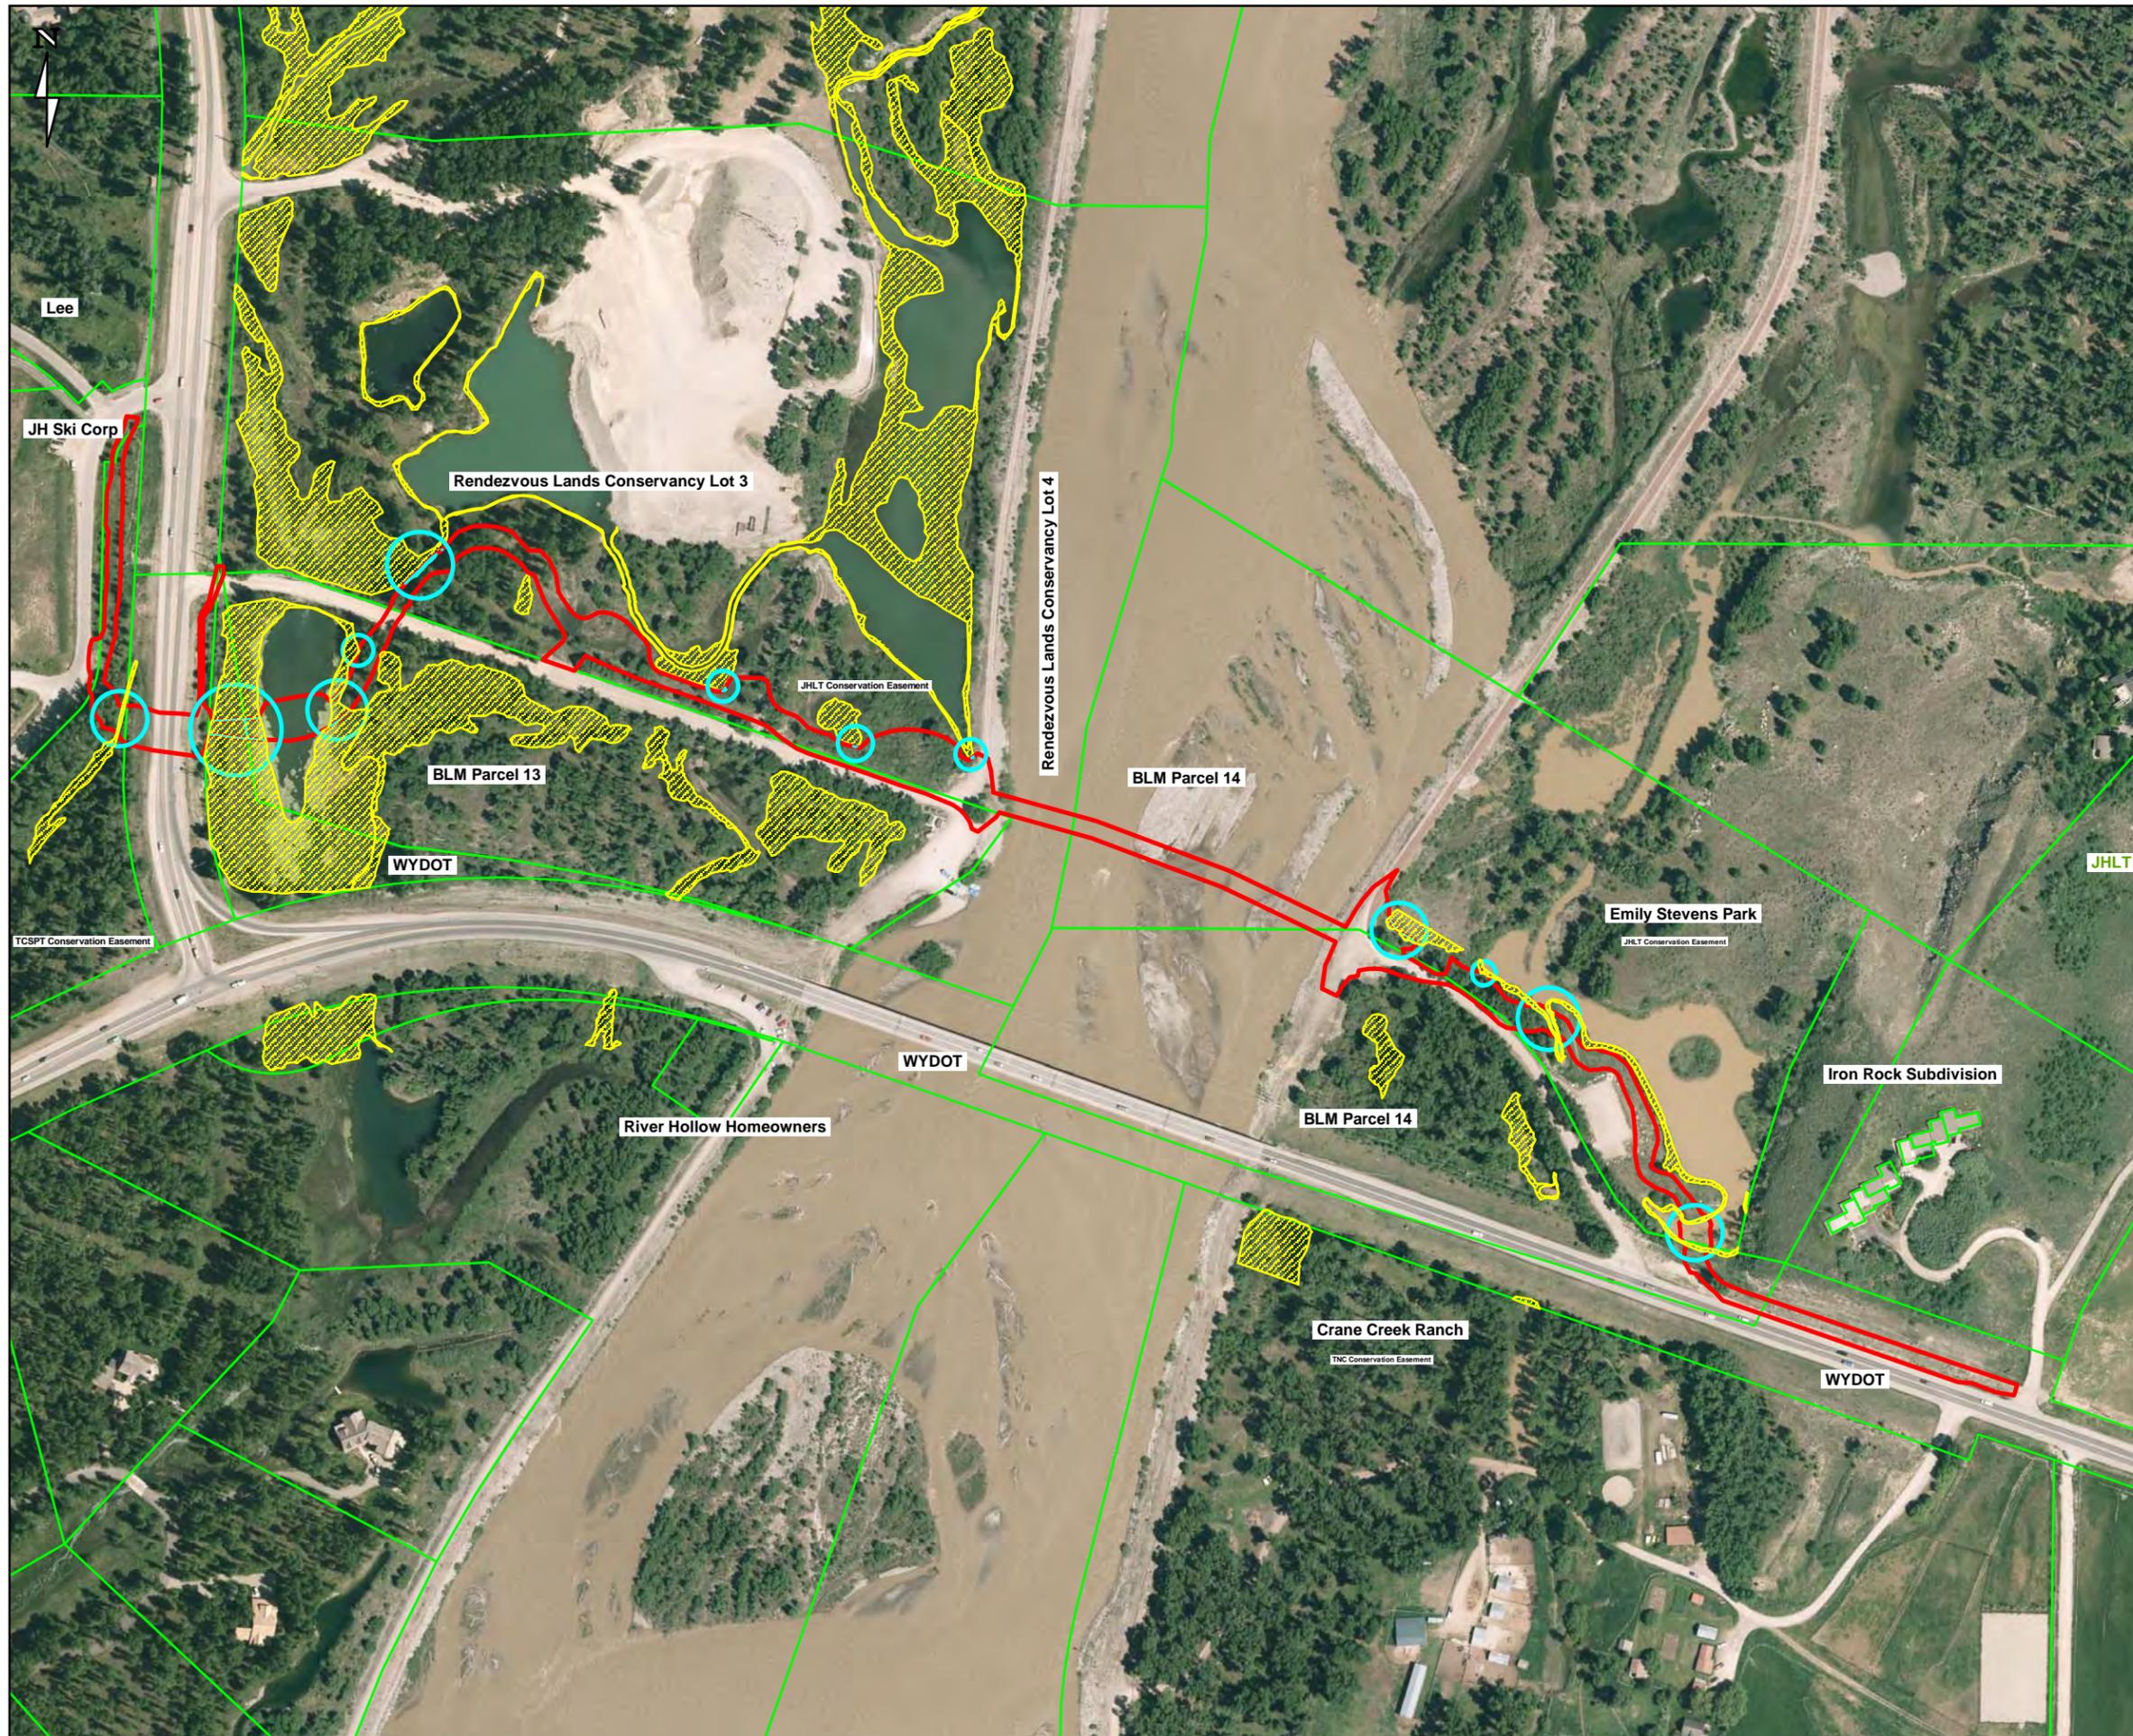
Attachment 4
 2011 aerial photograph depicting delineated
 wetlands within the Path 22 West project area,
 Teton County, Wyoming.

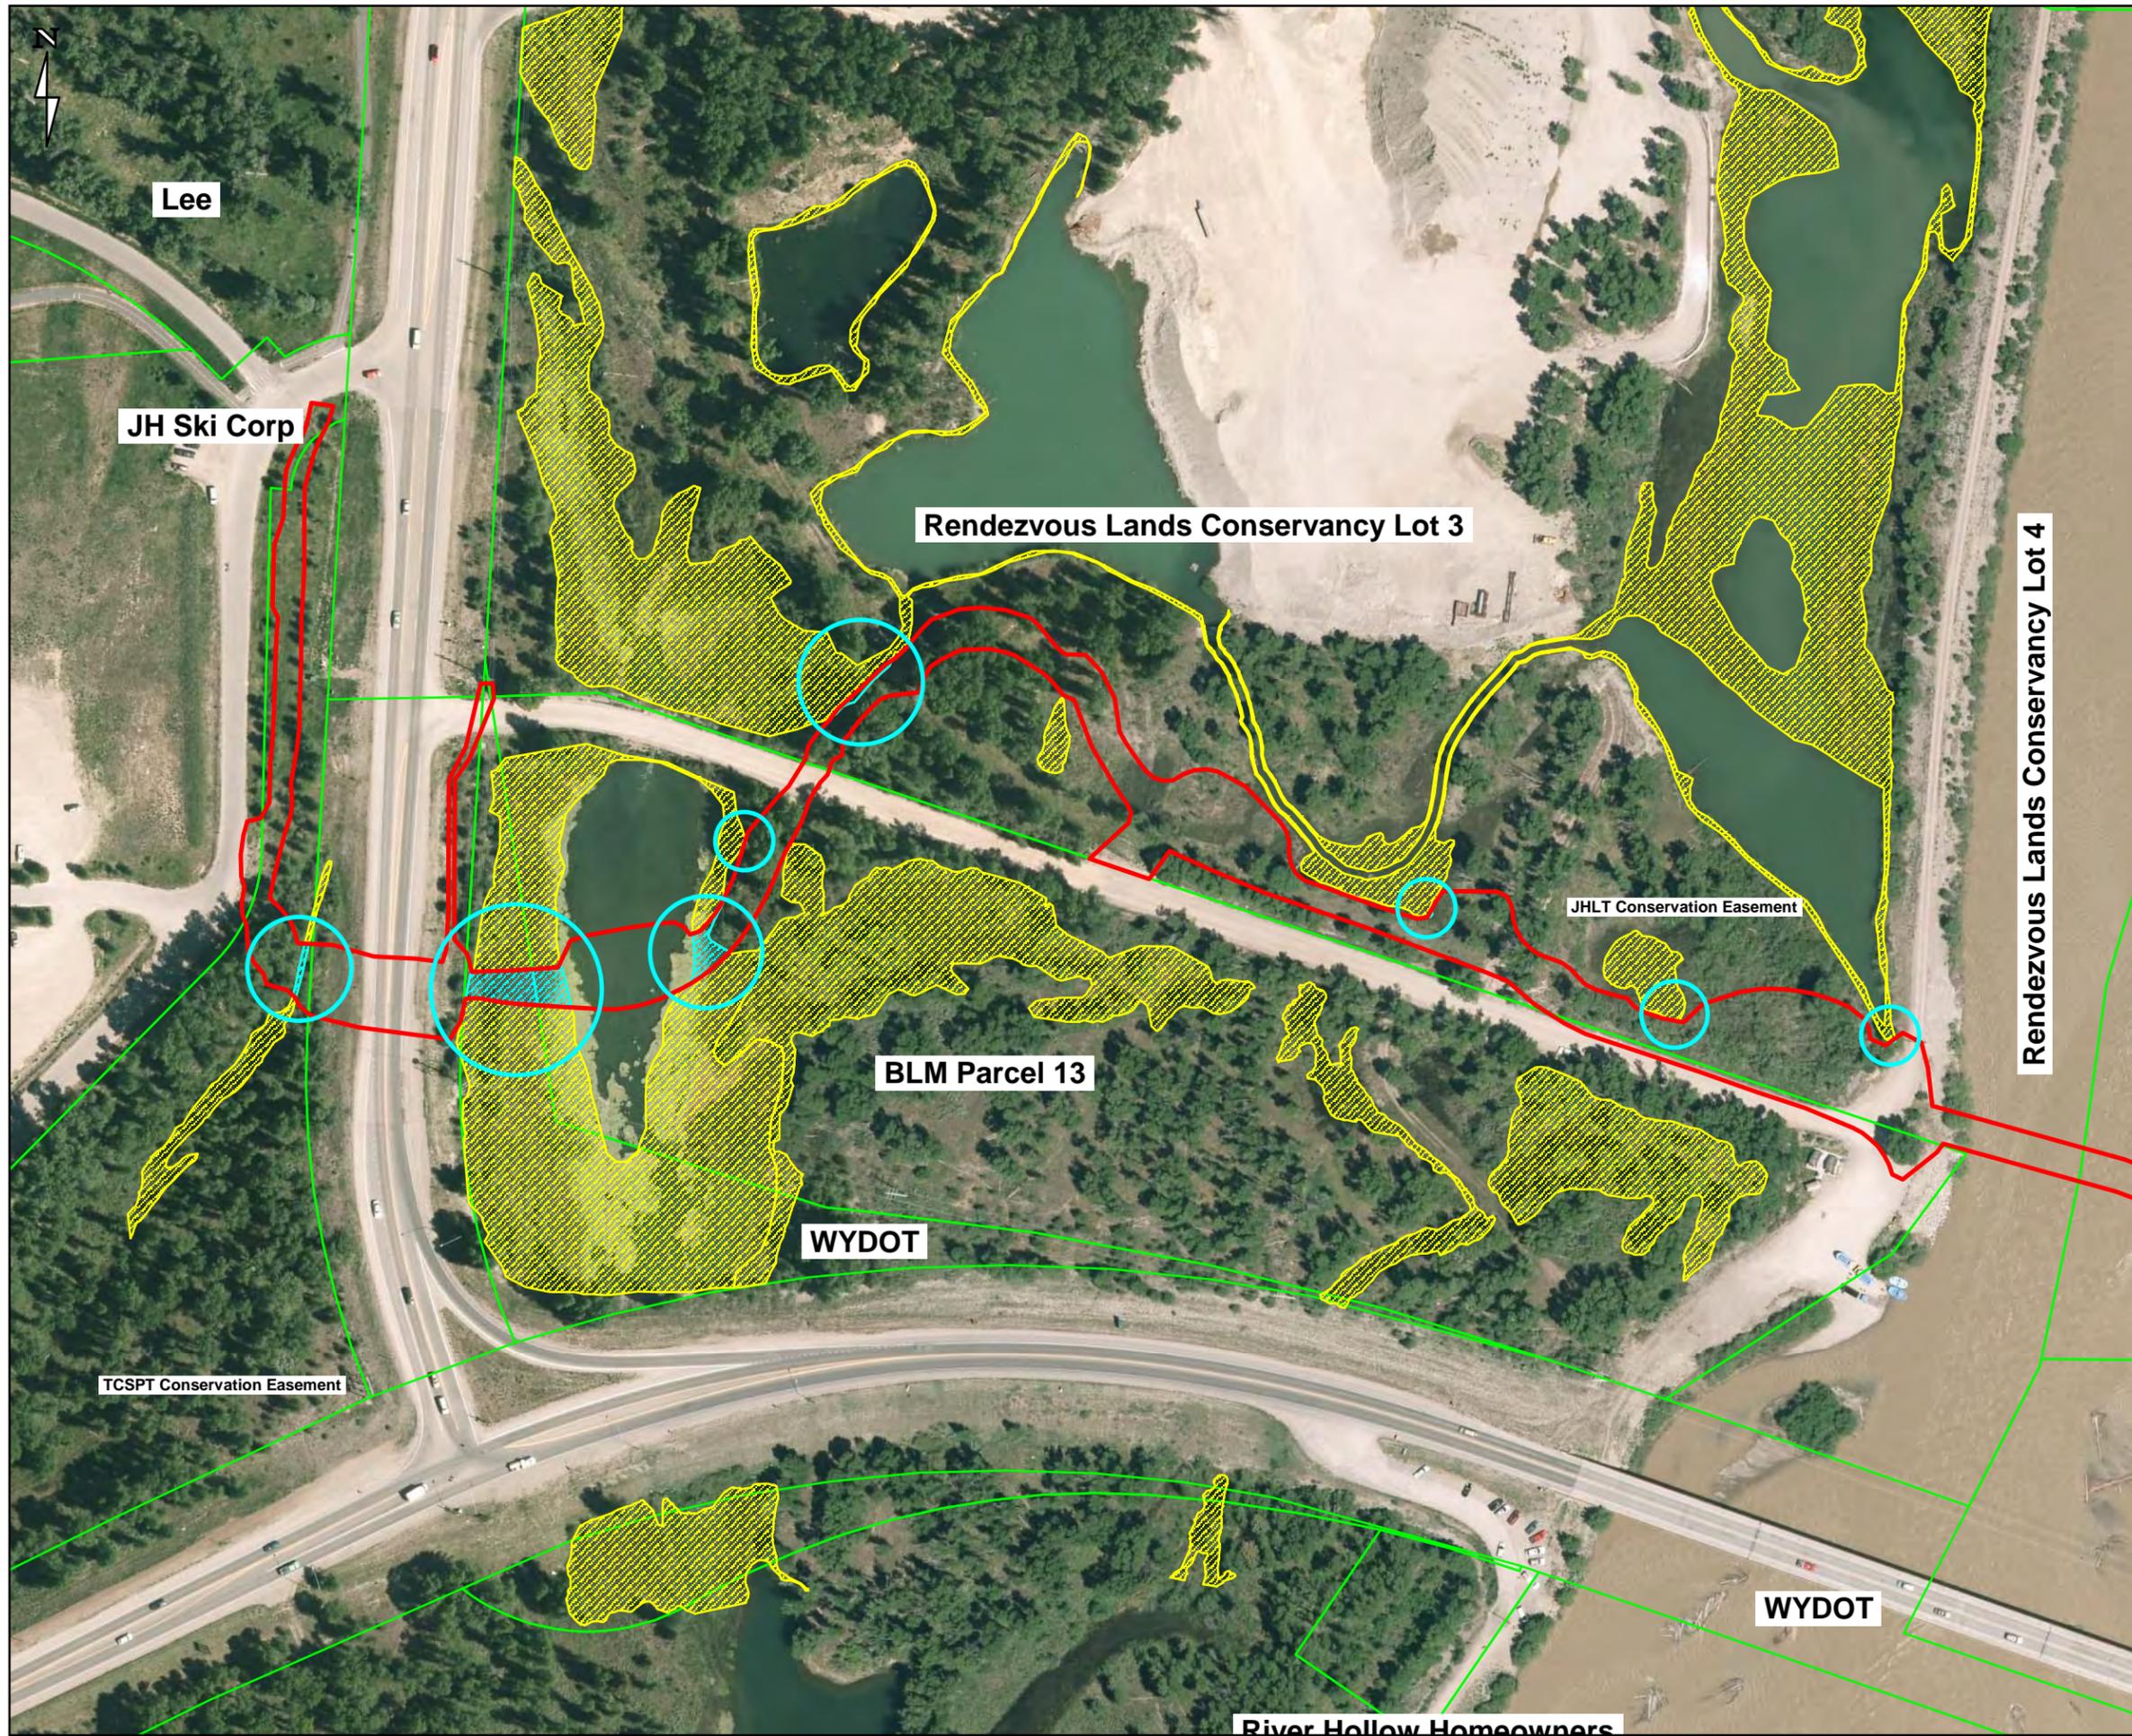
Attachment 5
 2011 aerial photograph depicting delineated wetlands and wetland impacts within the western portion of the Path 22 West project area, Teton County, Wyoming.

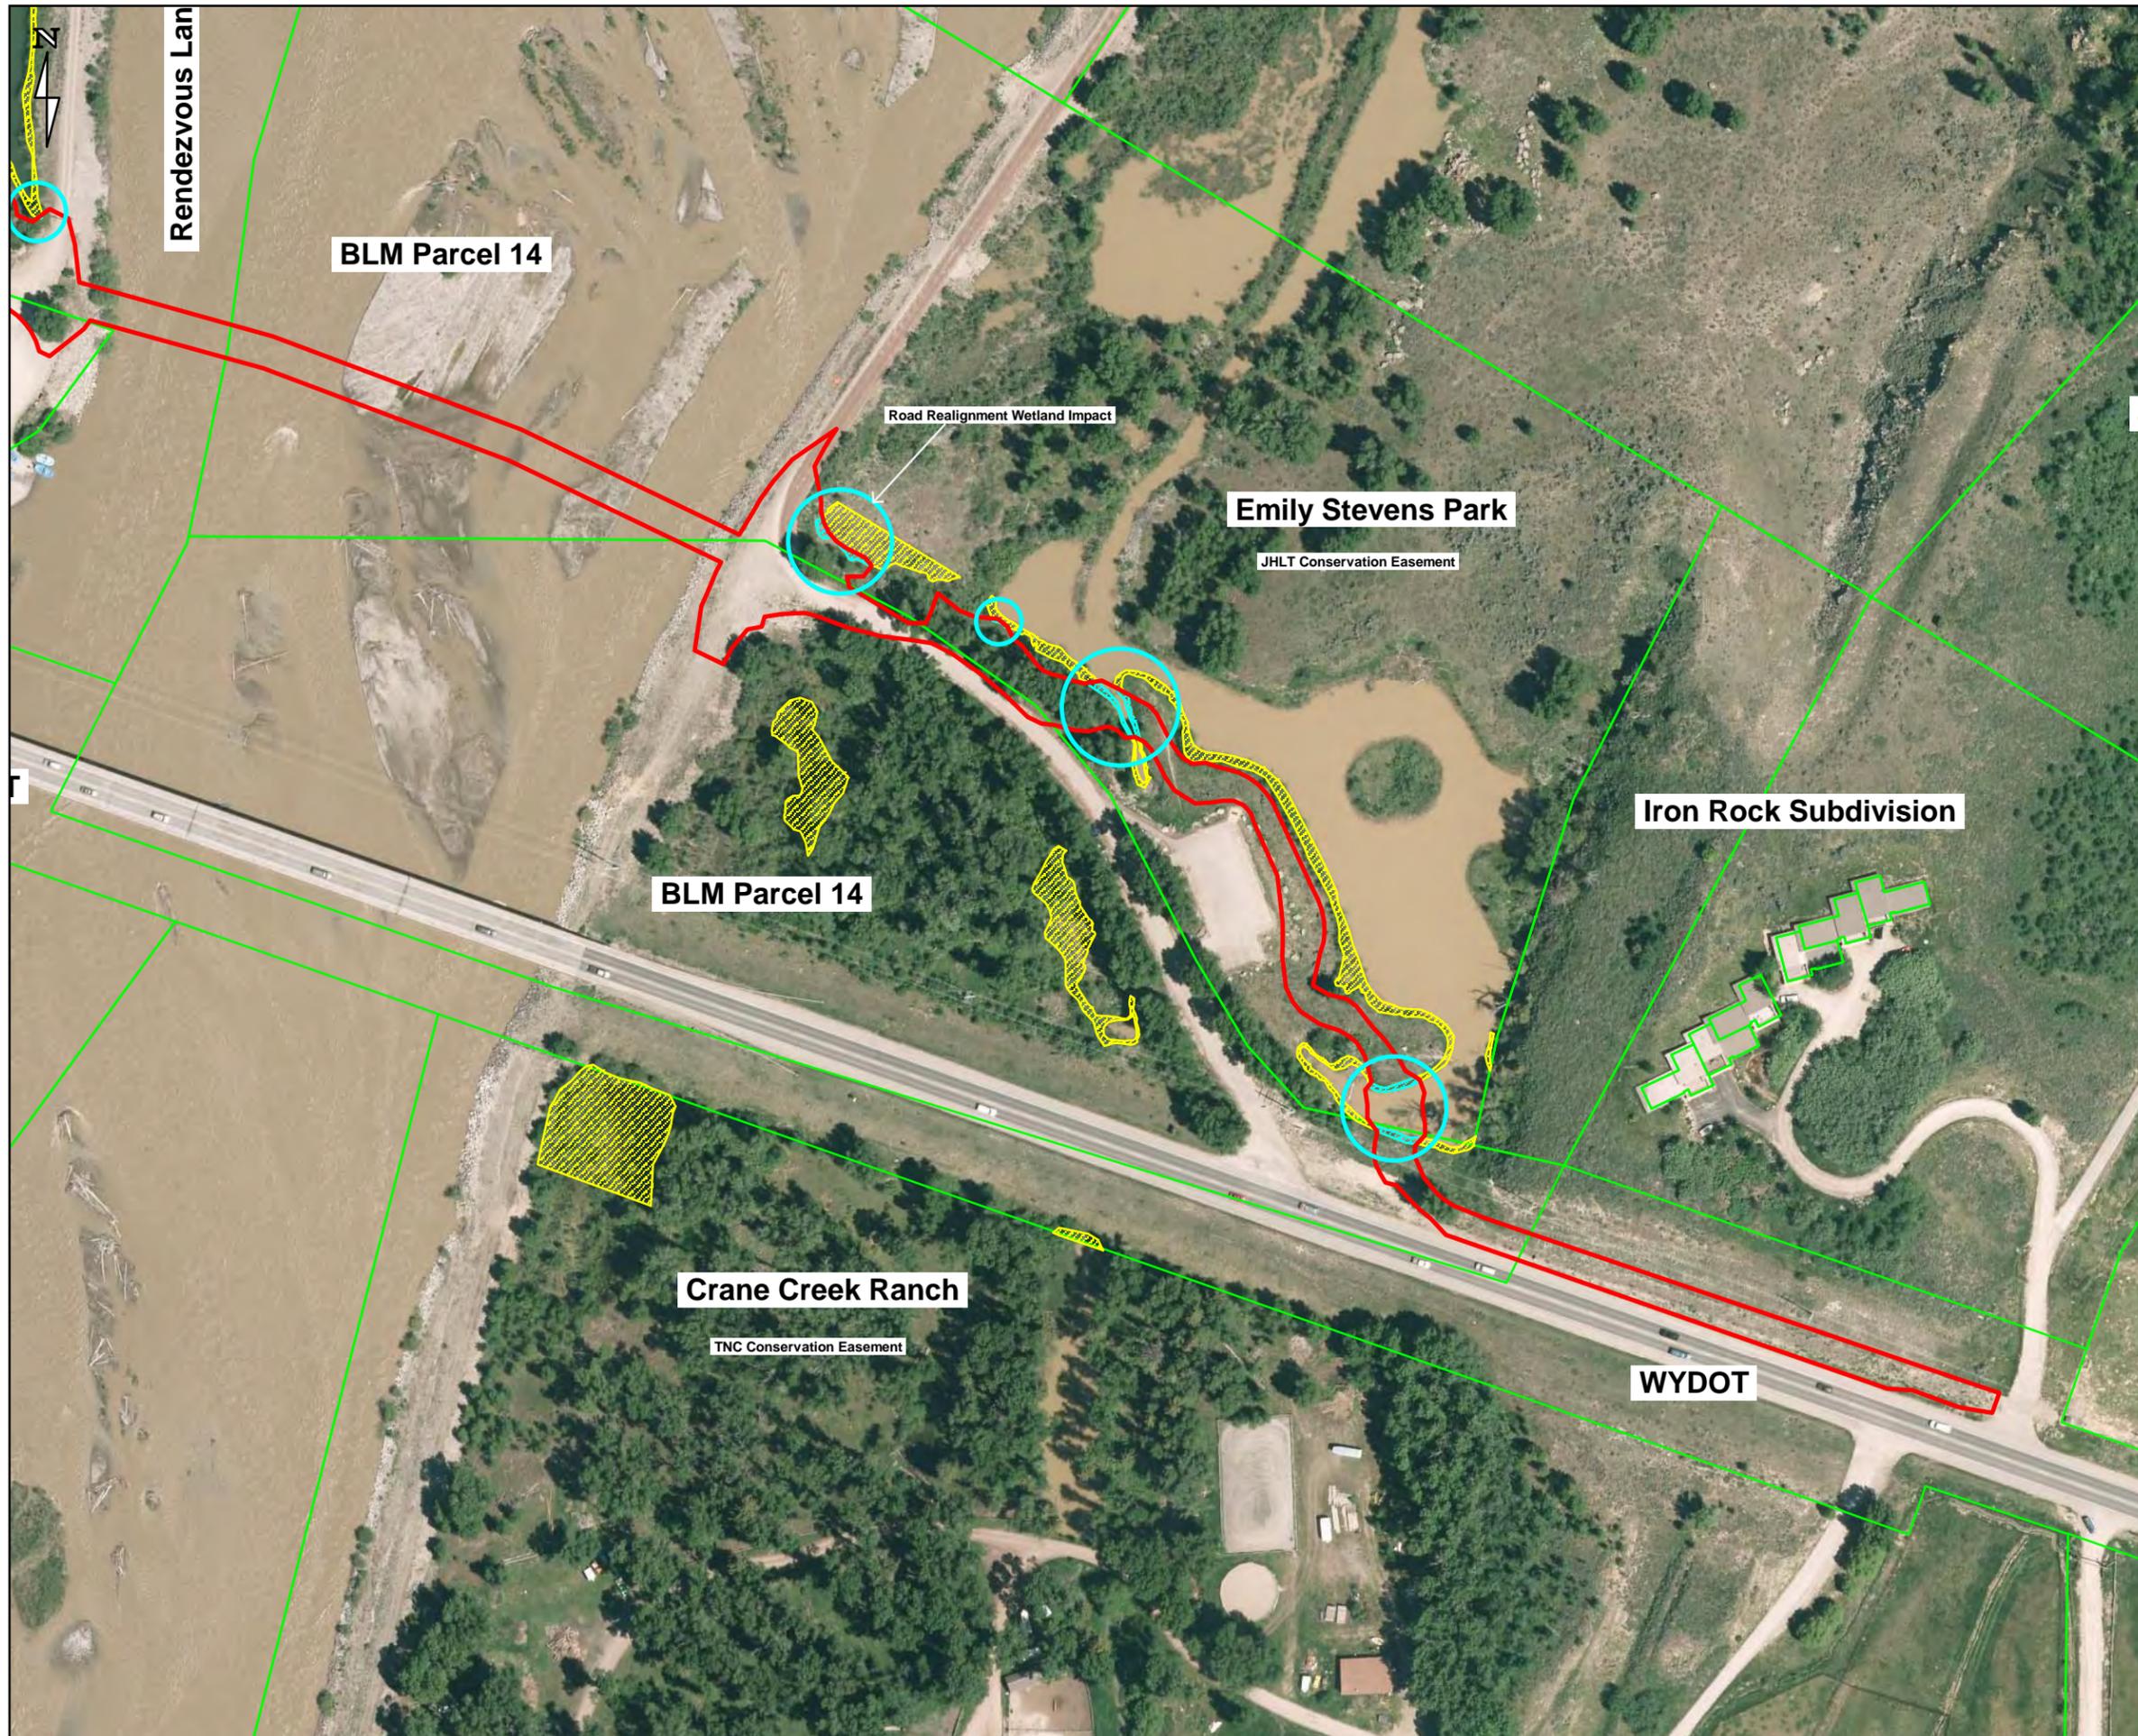
Attachment 6
 2011 aerial photograph depicting delineated
 wetlands and wetland impacts within the eastern
 portion of the Path 22 West project area,
 Teton County, Wyoming.

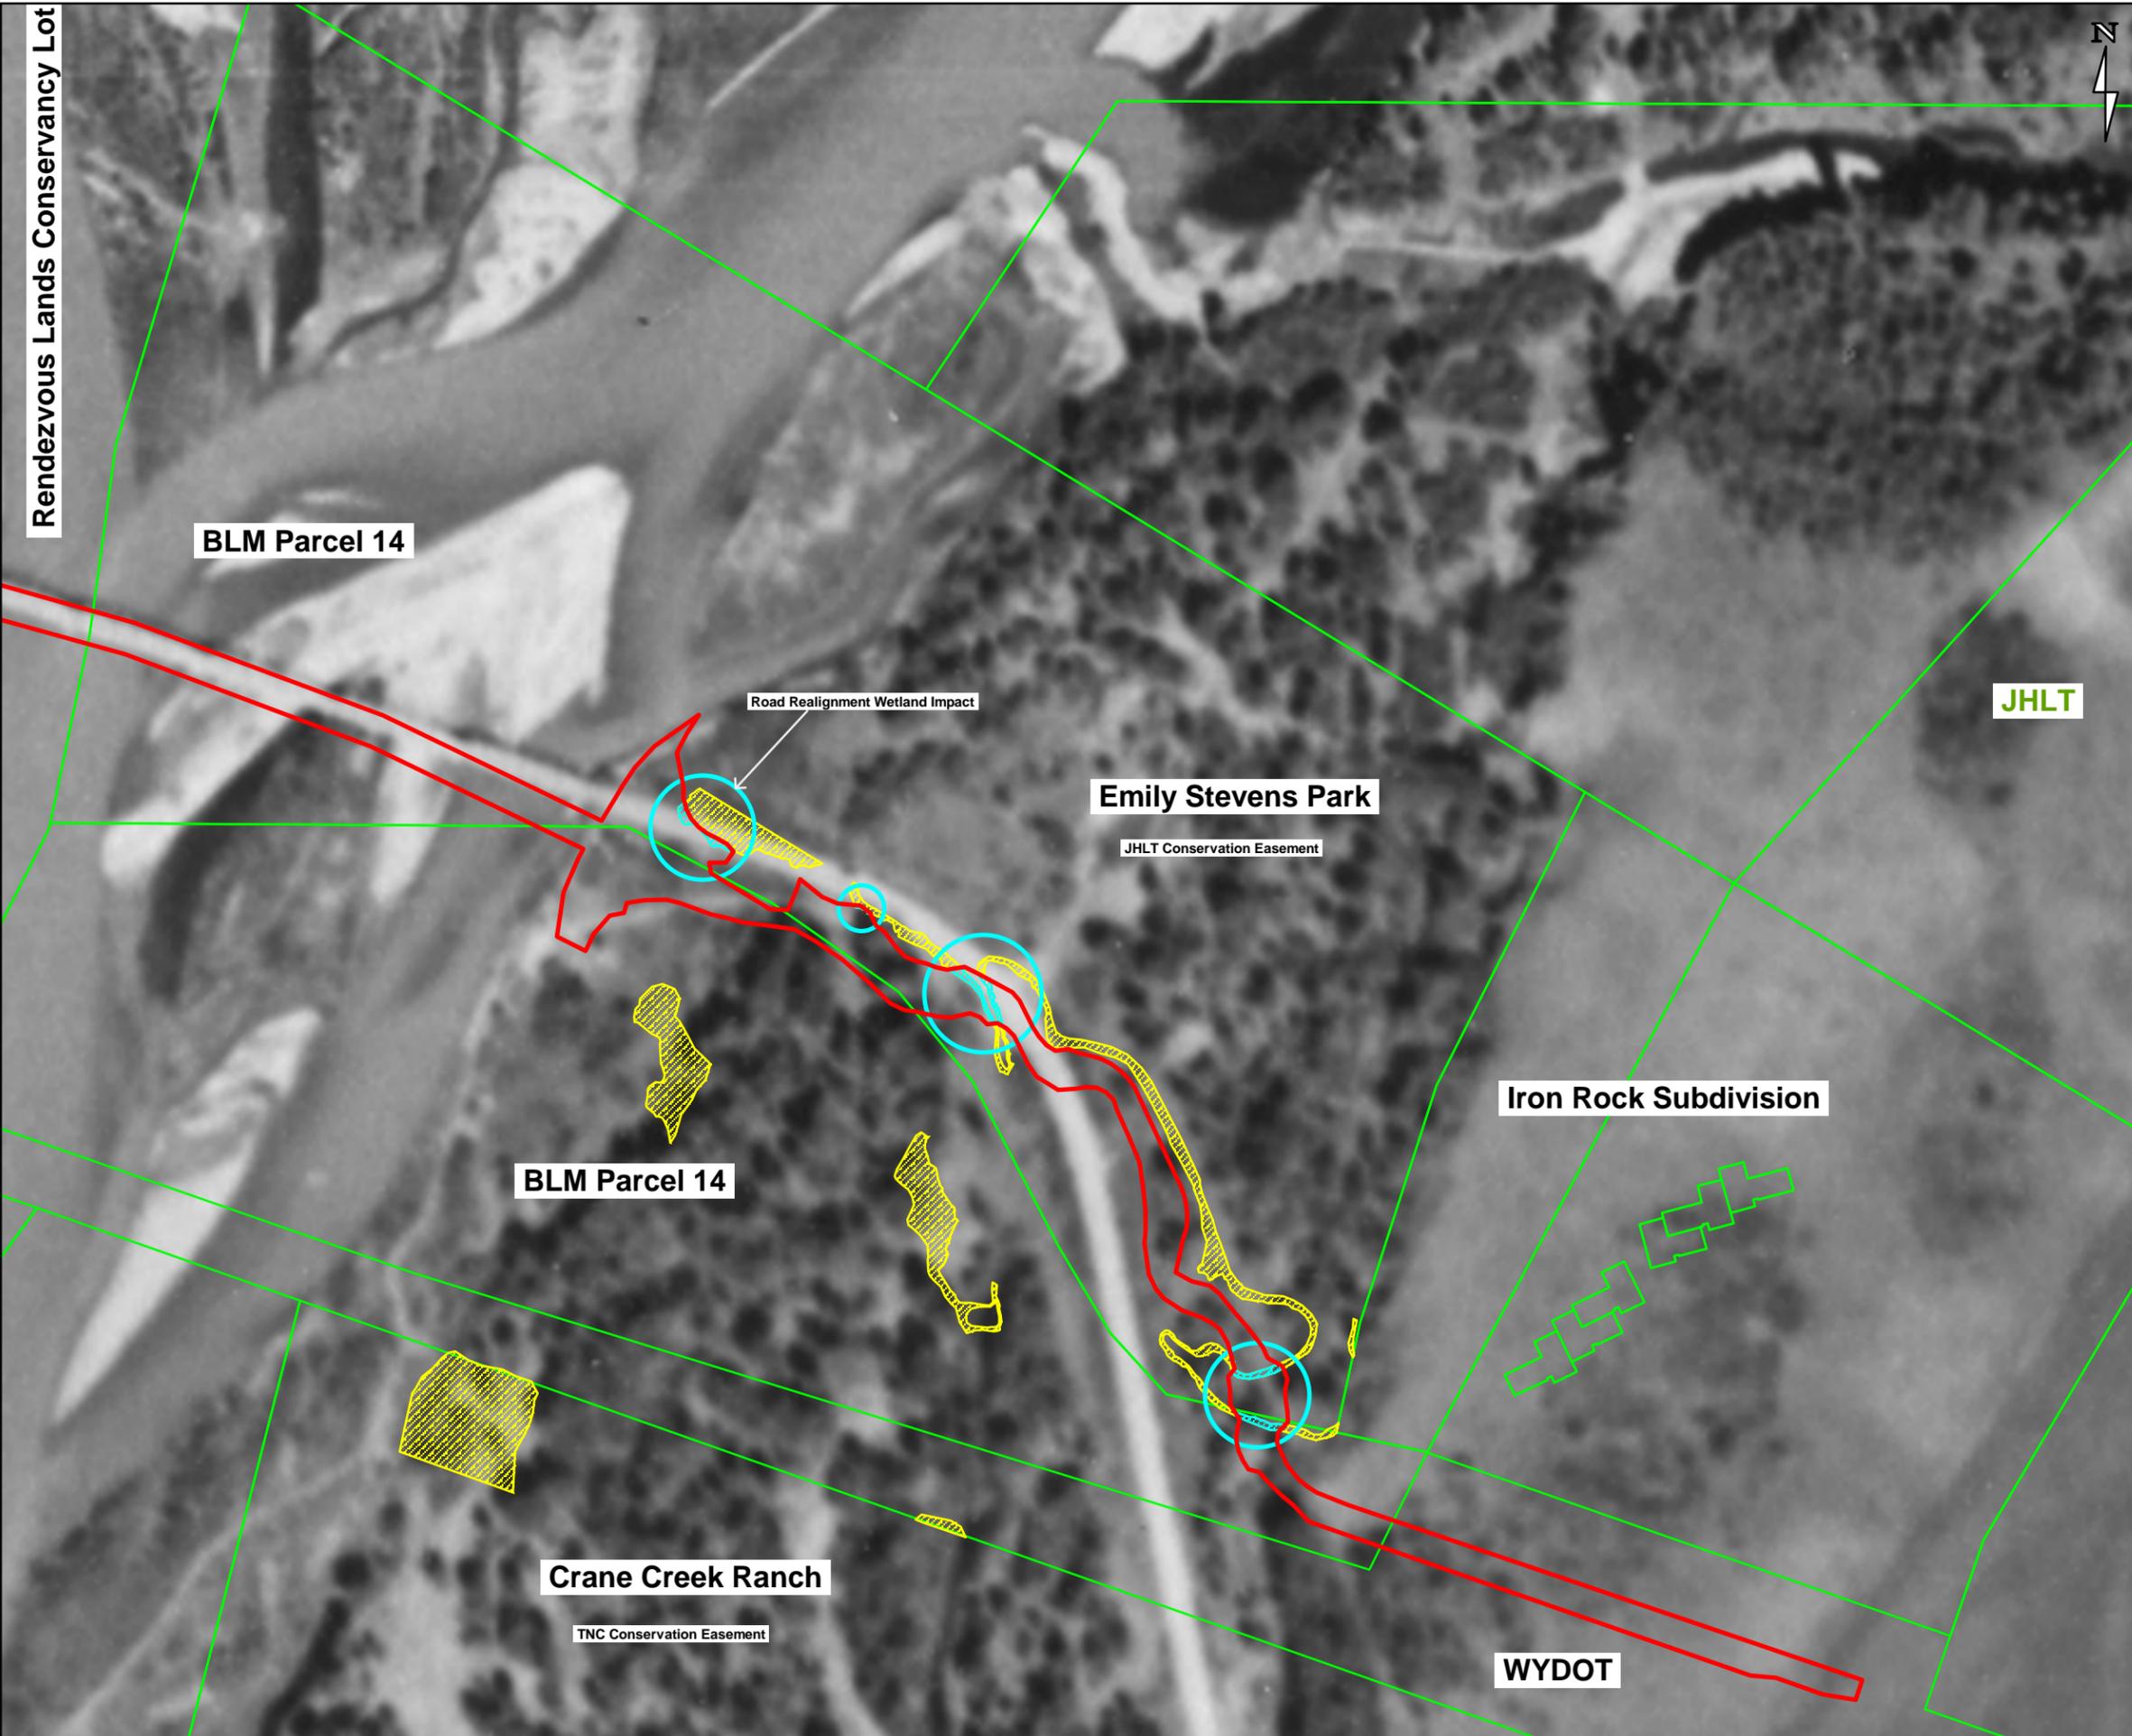
Attachment 7
1945 aerial photograph depicting 2011 delineated wetlands and wetland impacts within the eastern portion of the Path 22 West project area, Teton County, Wyoming.

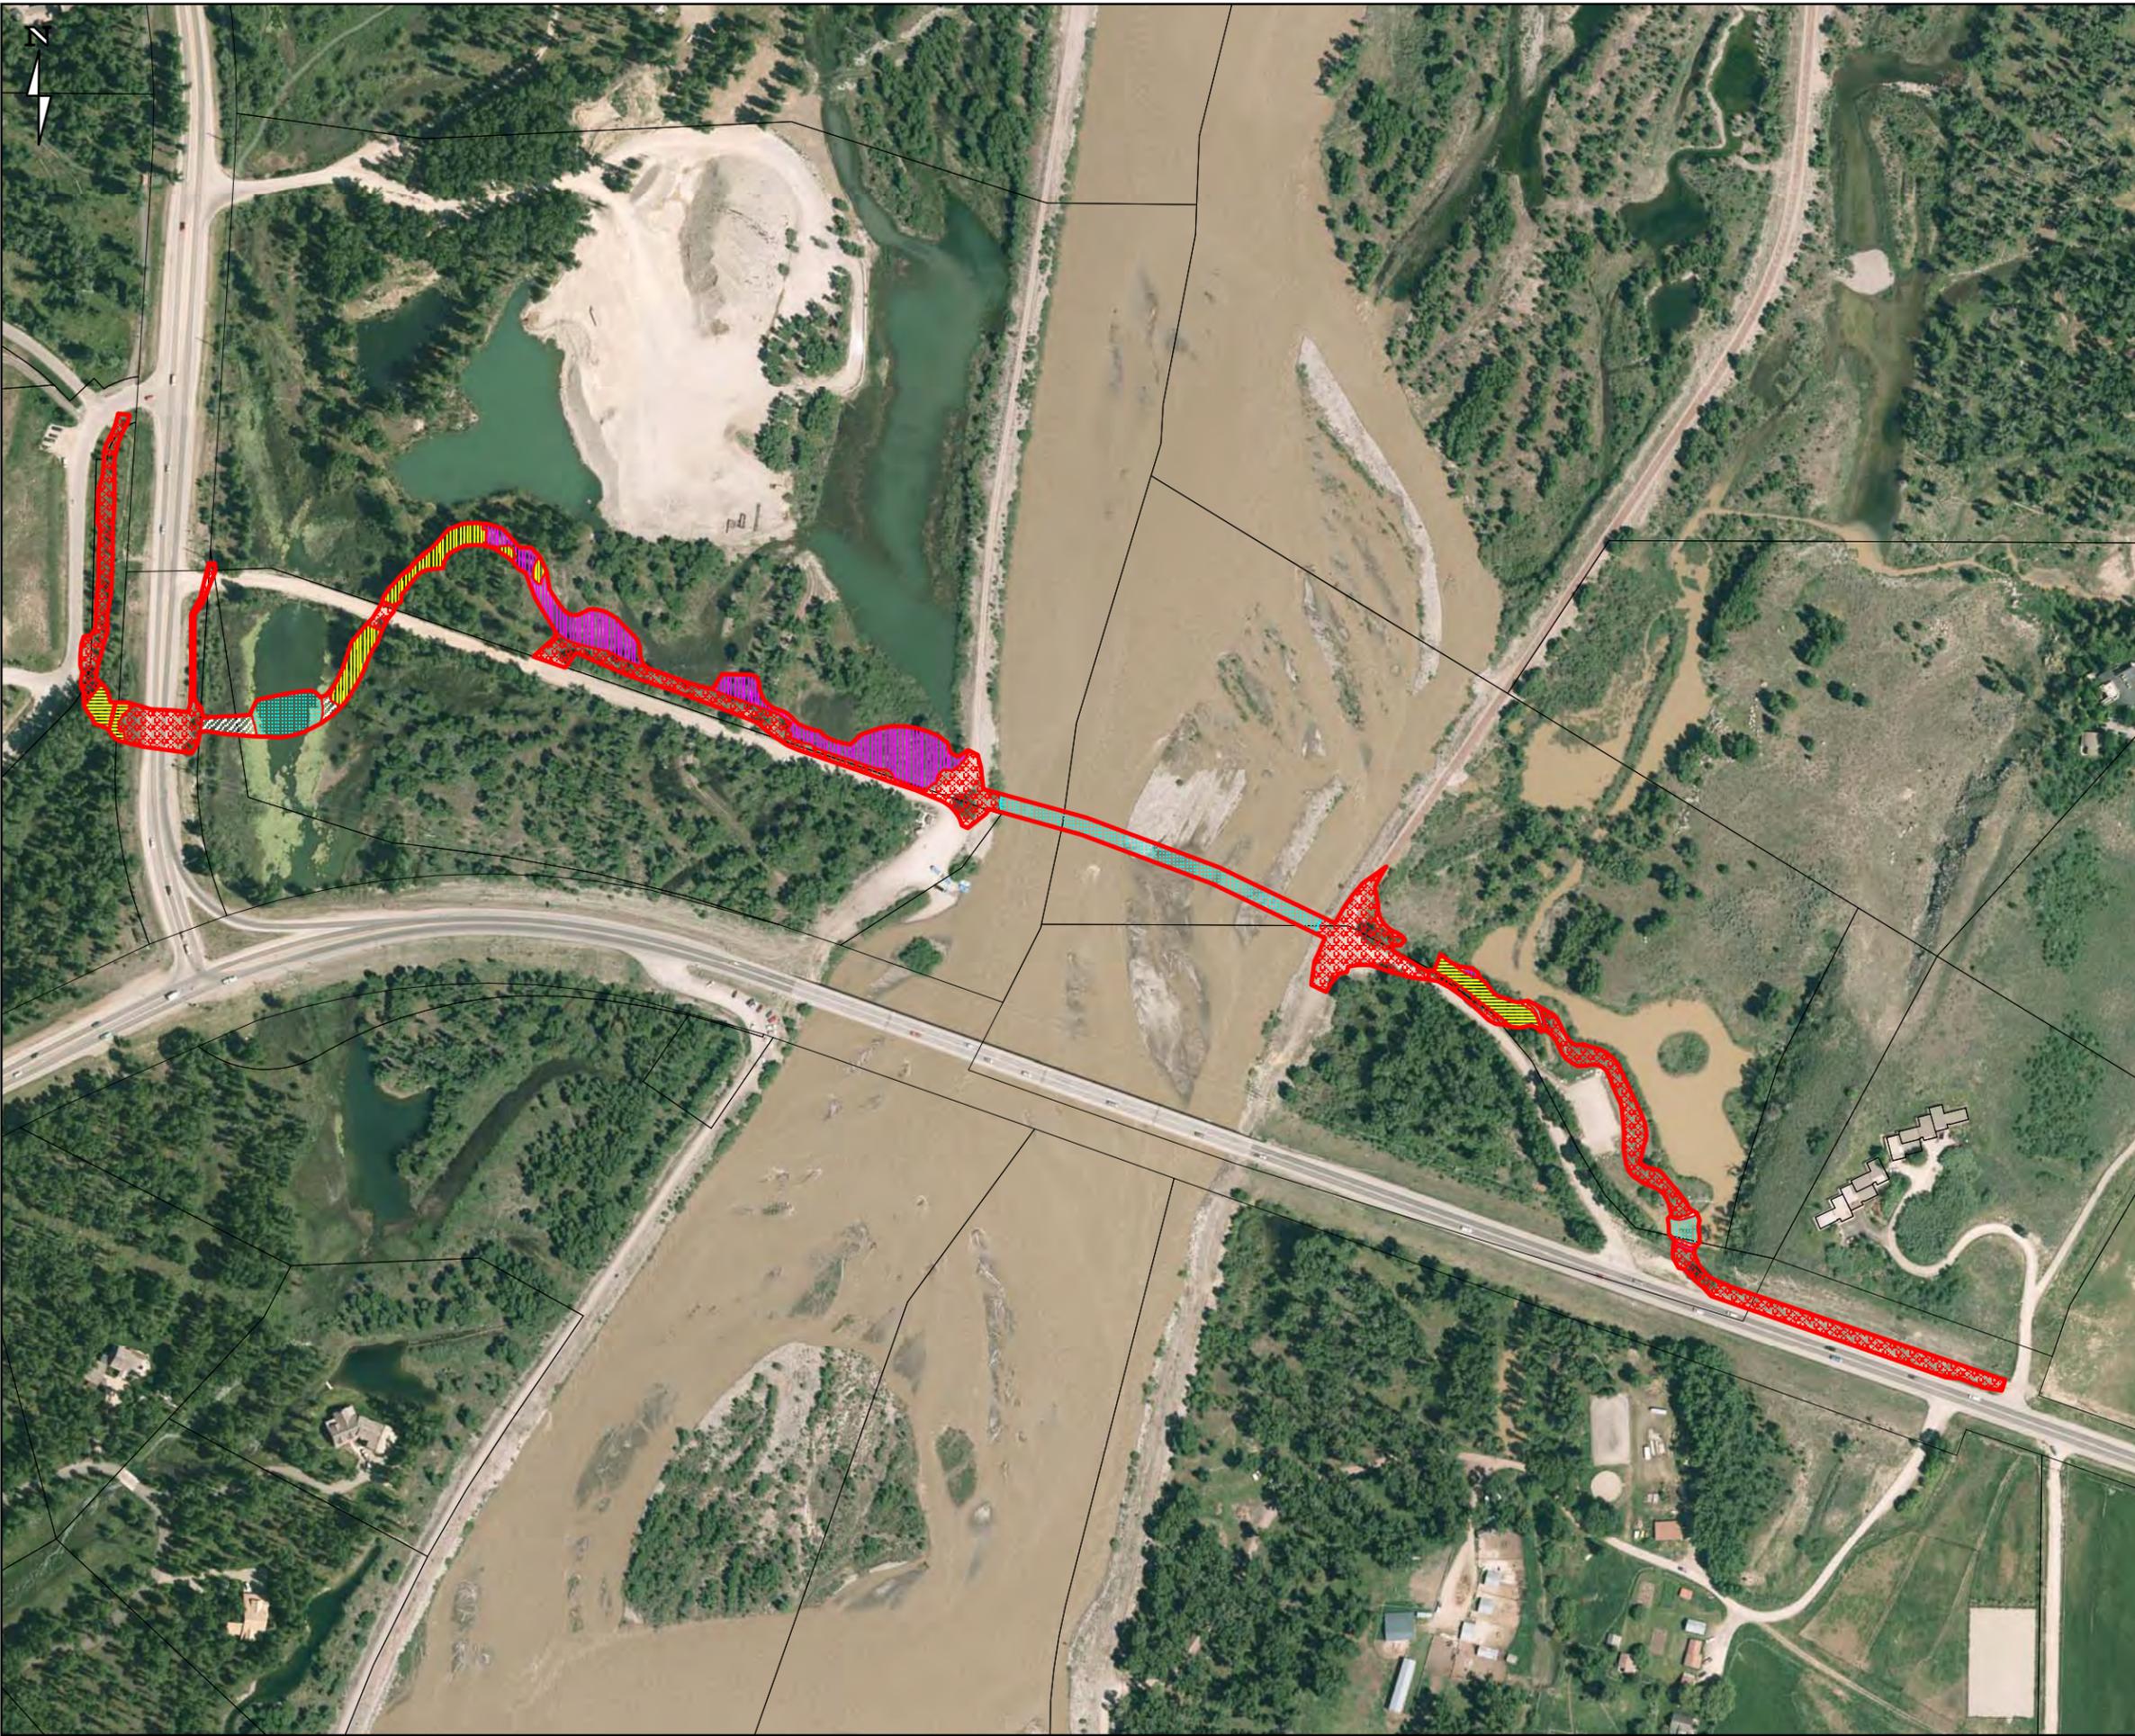
Attachment 8
 Aerial photograph depicting vegetative
 covertypes within the Path 22 West project
 area, Teton County, Wyoming.

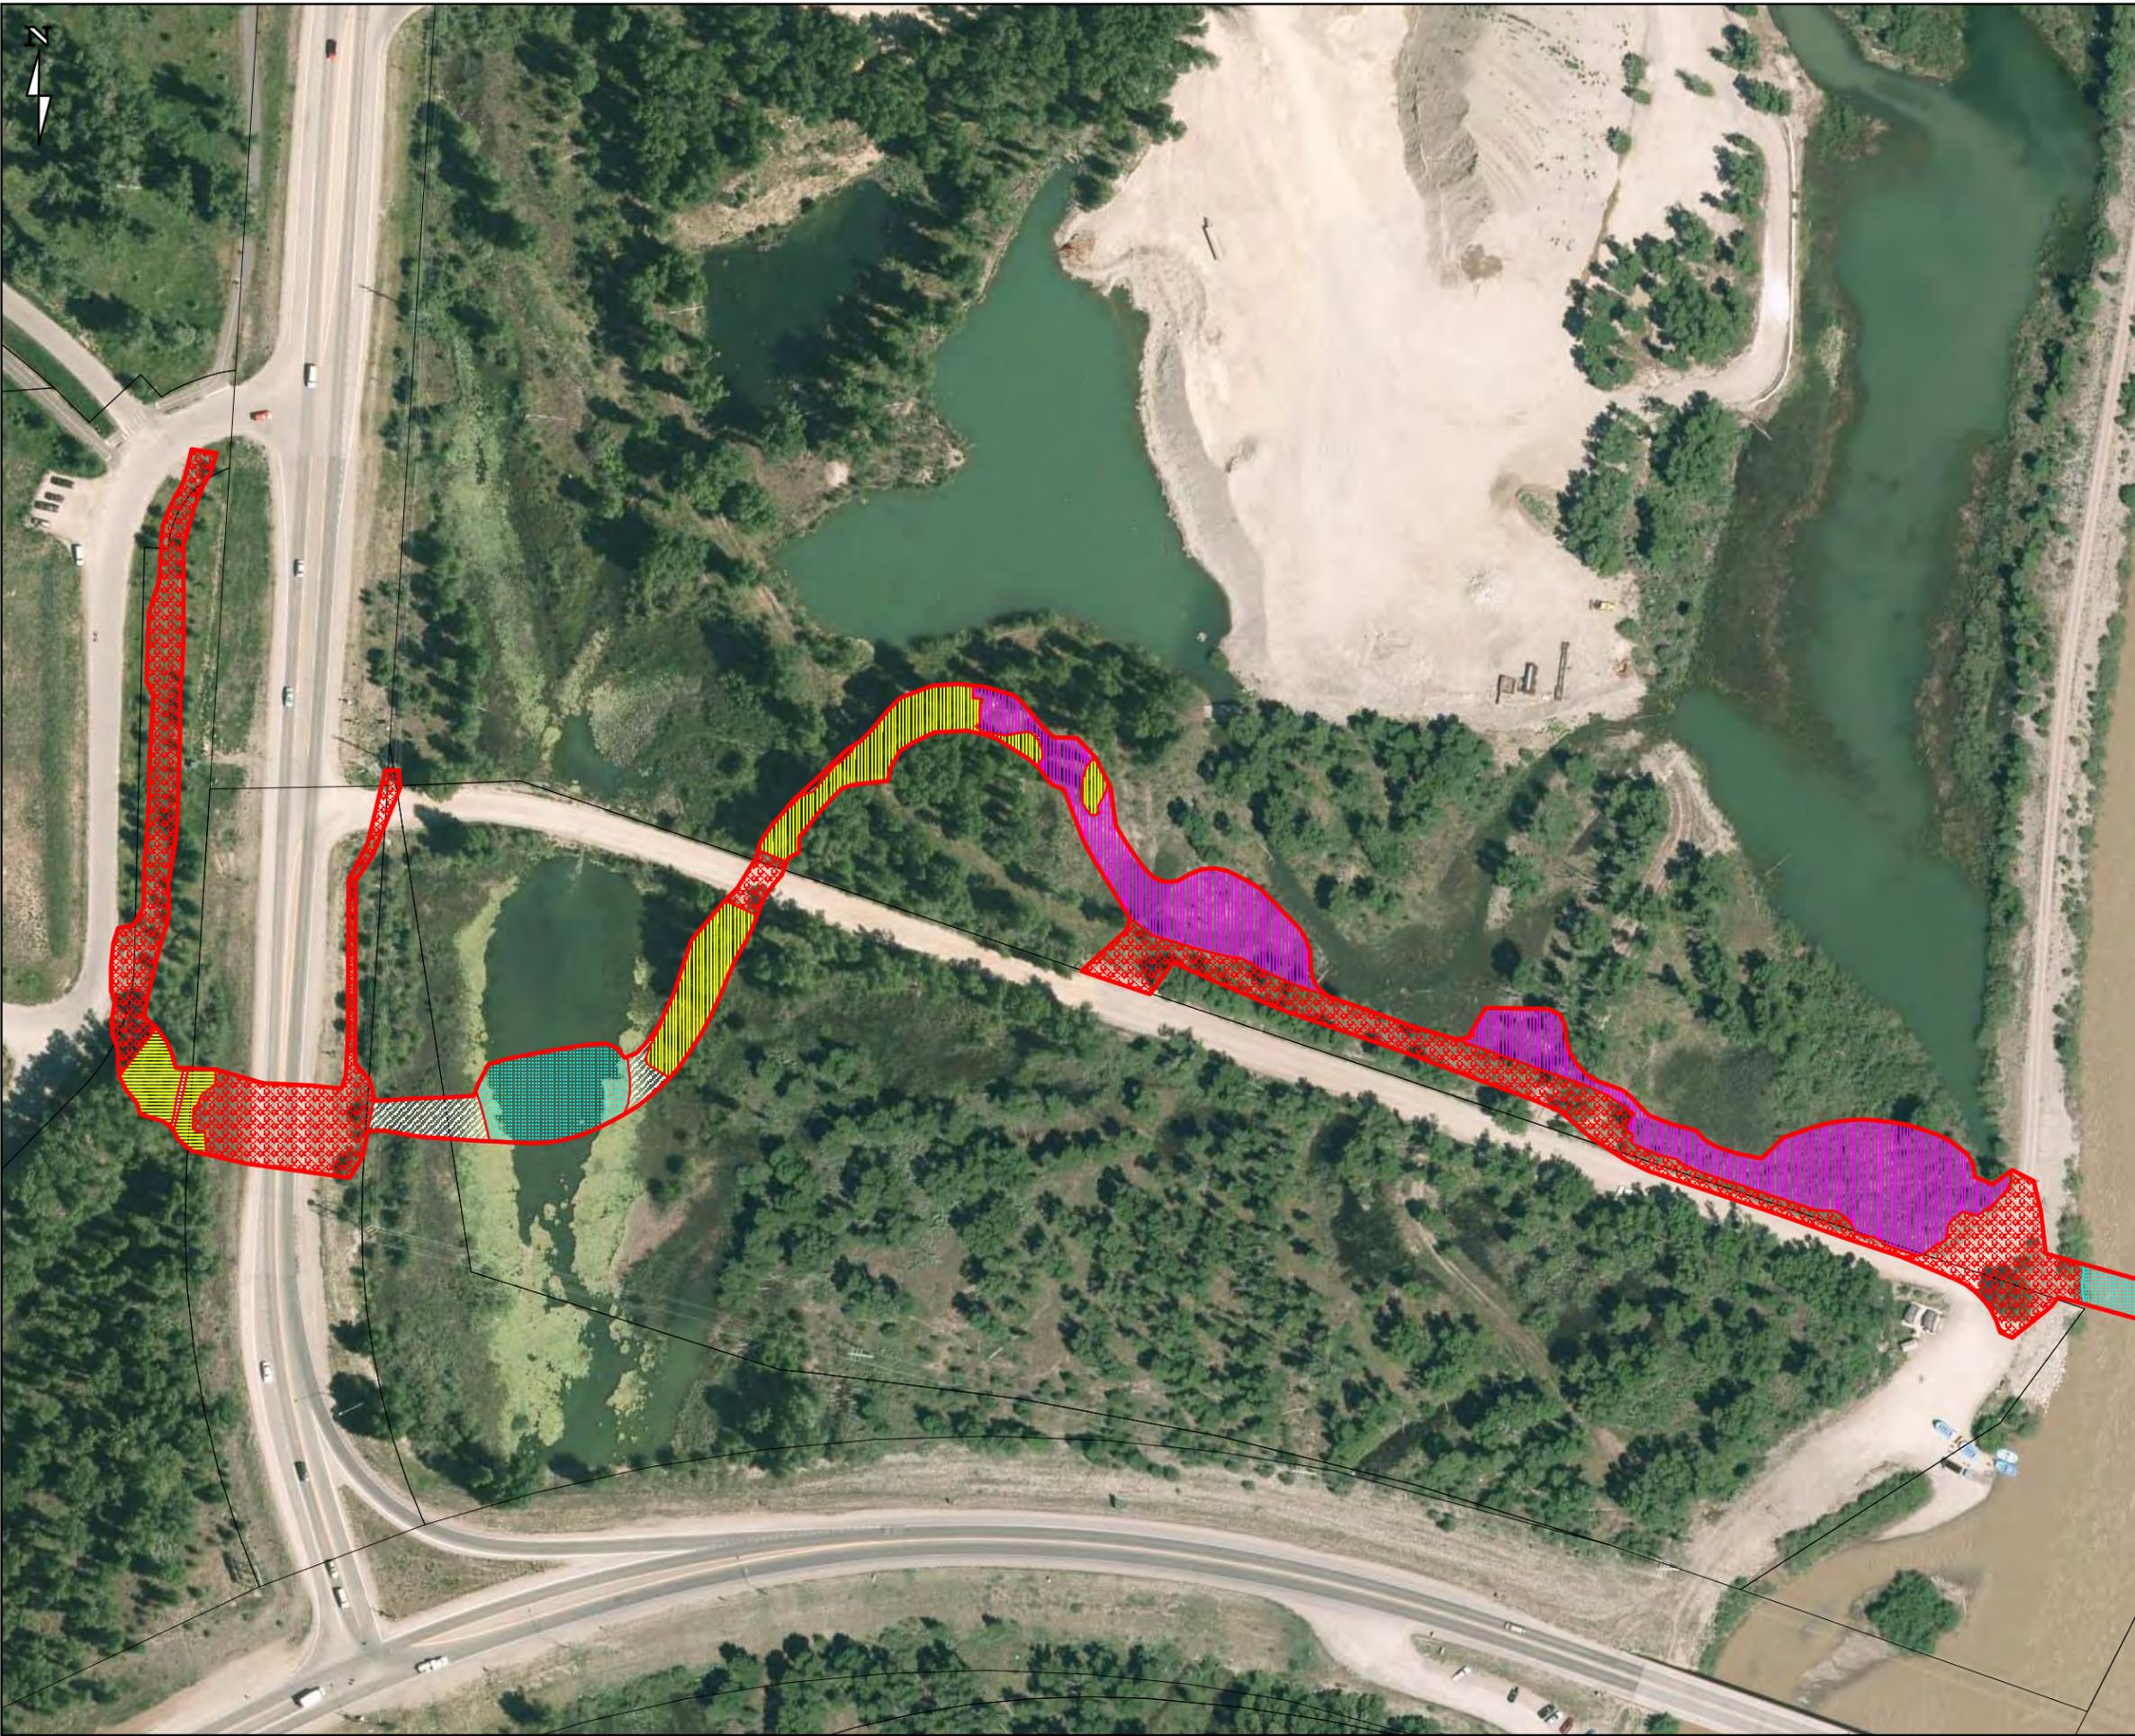
Attachment 9
 Aerial photograph depicting vegetative
 covertypes within the western portion of the
 Path 22 West project area,
 Teton County, Wyoming.
