Attachment 1
Location and topography of the Path 22 West
project area, Teton County, Wyoming.

Attachment 2
 2011 aerial photograph depicting alignment and
 land ownership of the Path 22 West project area,
 Teton County, Wyoming.

Attachment 3
 2011 aerial photograph depicting surface water
 features within the Path 22 West project area,
 Teton County, Wyoming.

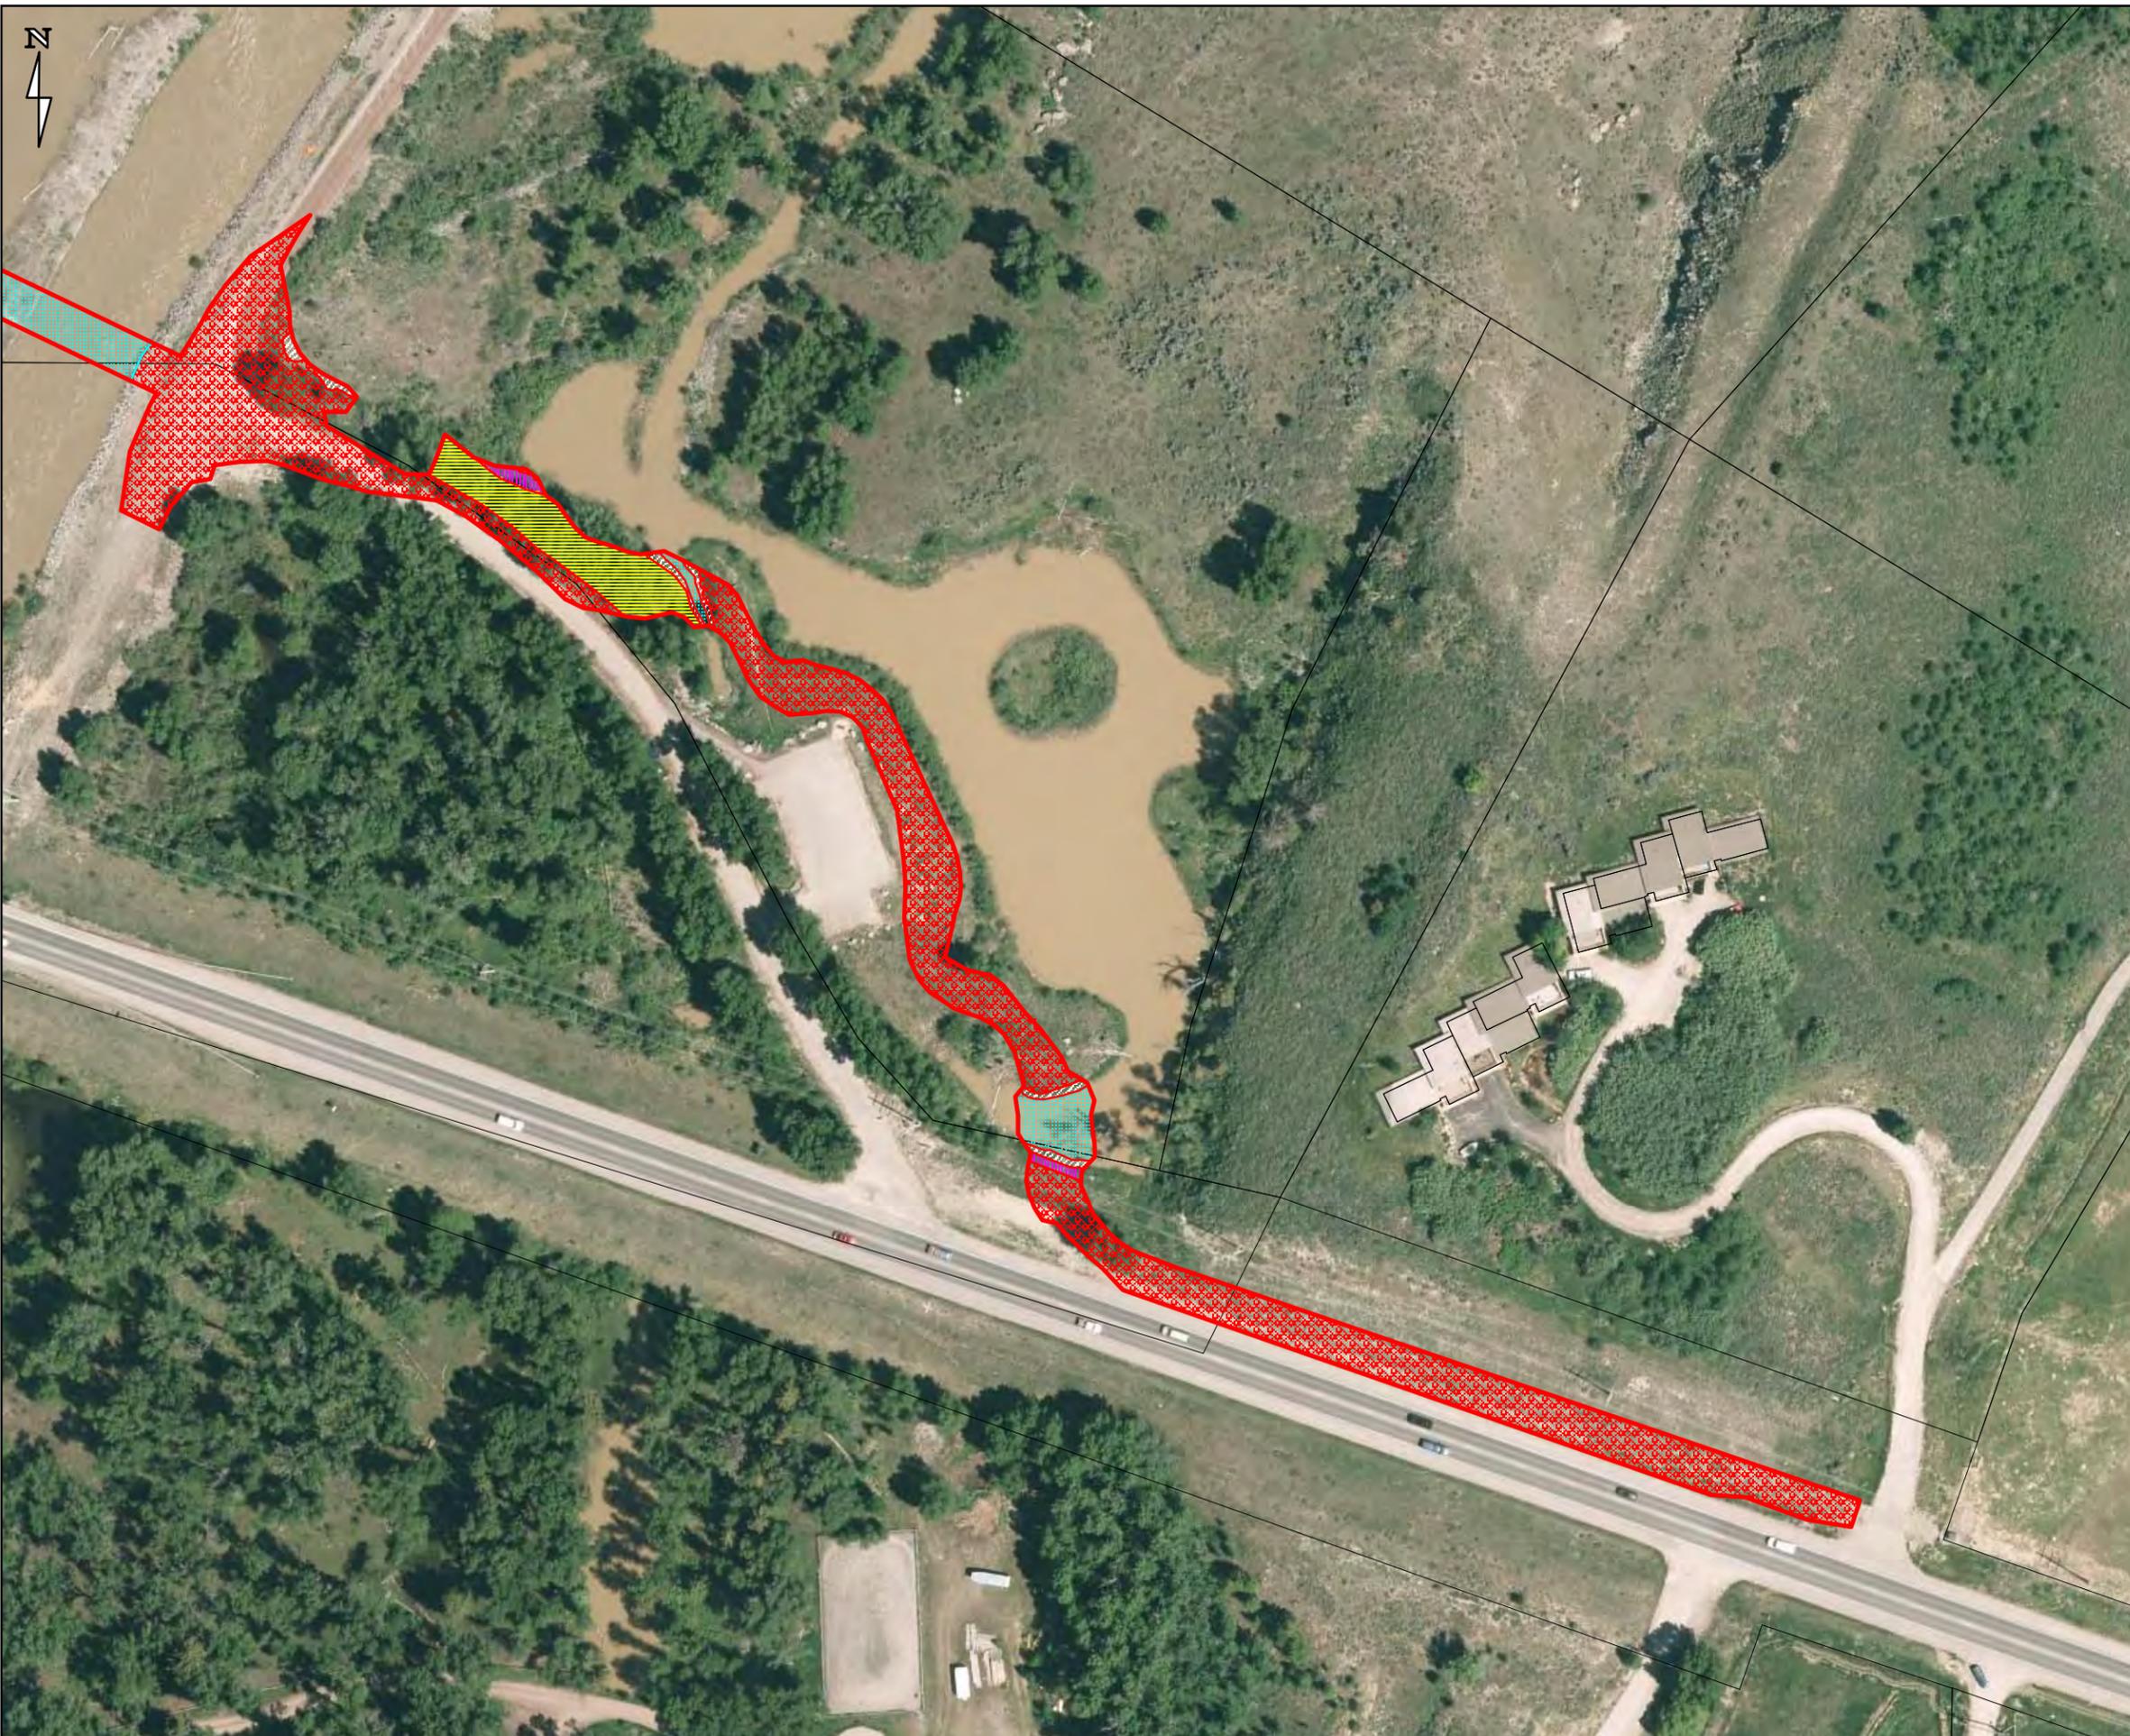
Attachment 10
 Aerial photograph depicting vegetative
 covertypes within the eastern portion of the
 Path 22 West project area,
 Teton County, Wyoming.

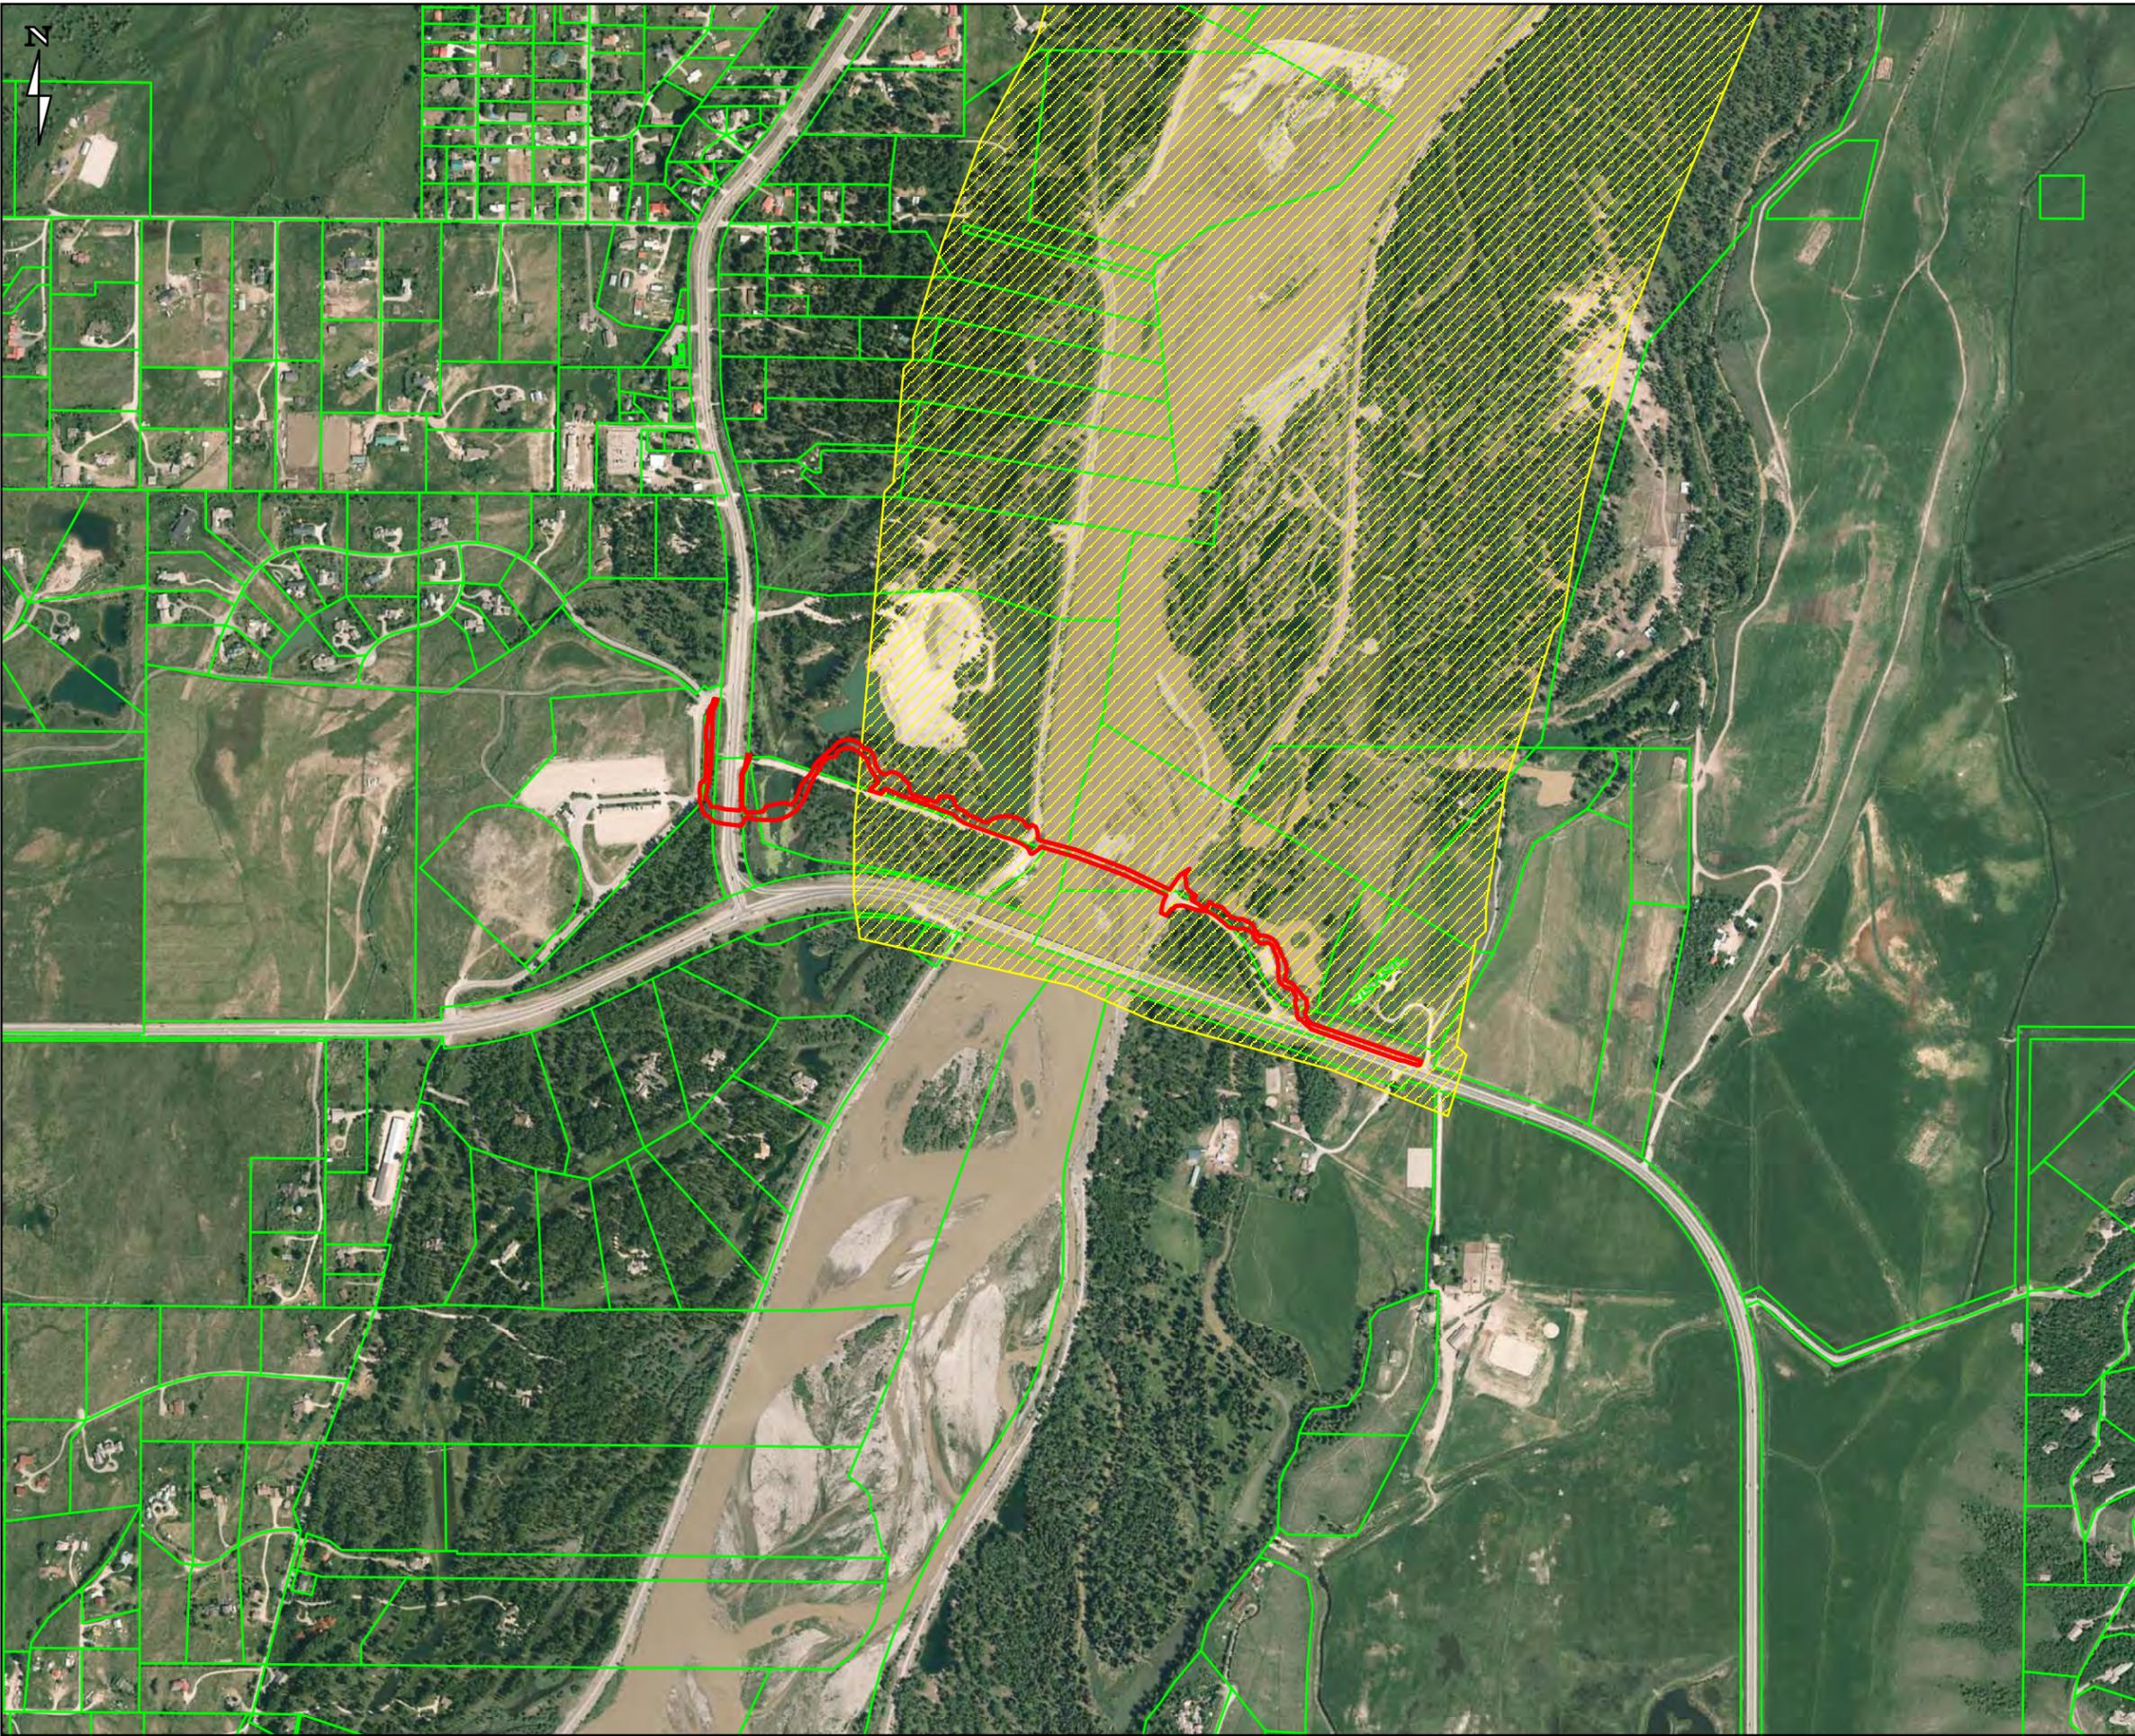
Attachment 11
2011 aerial photograph depicting crucial moose
winter yearlong range within and in the vicinity of
the Path 22 West project area,
Teton County, Wyoming.
